# Bright Light Inspections LLC

## Inspection Report

**12220 N Seneca St  
Sedgwick, KS 67135**

Inspected on Wed, Aug 20 2025 at 08:30

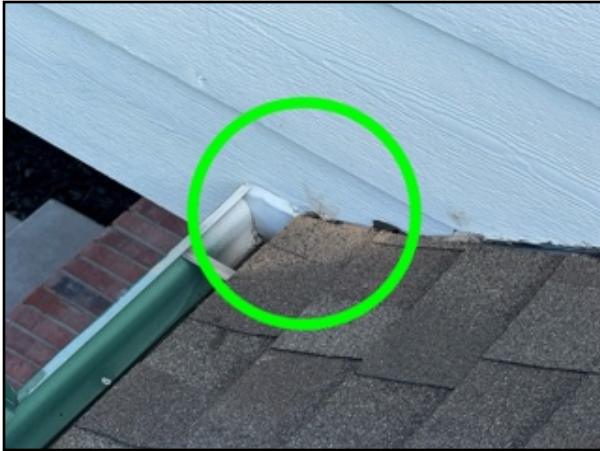
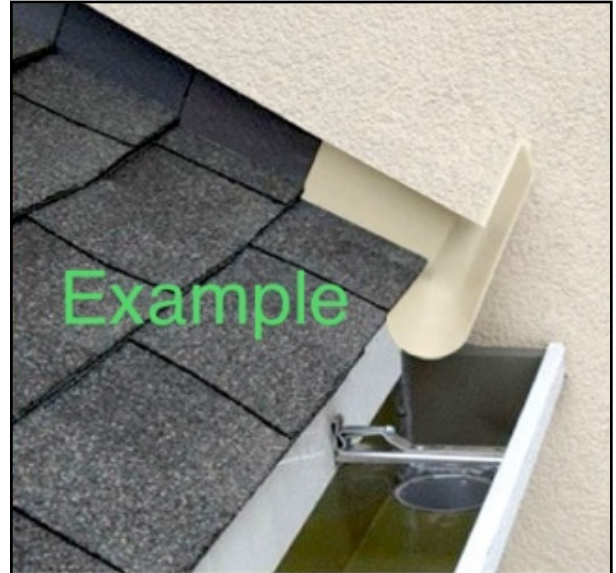
1) Comment 2: The home had no kick-out flashing installed where walls extended past roof edges. Kick-out flashing diverts water from behind the exterior wall covering at areas of the home where a sidewall extends out past a roof eave. The Inspector recommends consulting with a qualified roofing contractor to discuss options and costs for replacement.

The home had no kick-out flashing installed where walls extended past roof edges. Kick-out flashing diverts water from behind the exterior wall covering at areas of the home where a sidewall extends out past a roof eve. The Inspector recommends consulting with a qualified roofing contractor to discuss options and costs for replacement.

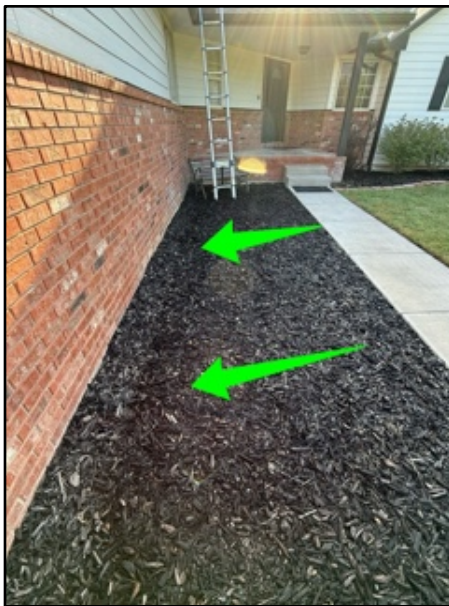
Figure 4-1

The property had areas where the ground slopes toward the foundation, creating neutral or negative drainage. This condition can lead to water pooling near the home and may contribute to foundation issues over time. The inspector recommends regrading these areas so the soil slopes away from the foundation for at least six feet to promote proper drainage and to help protect the structure.

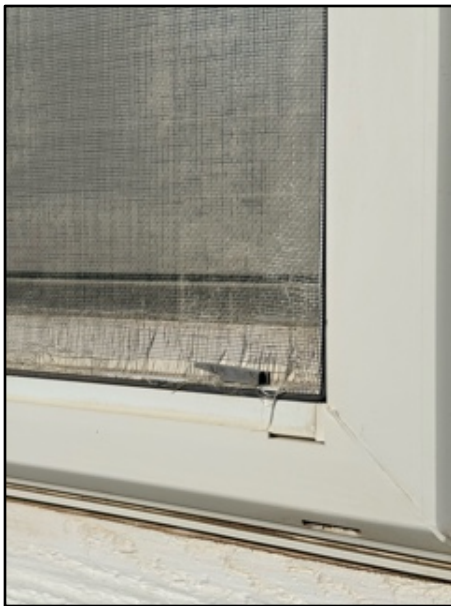
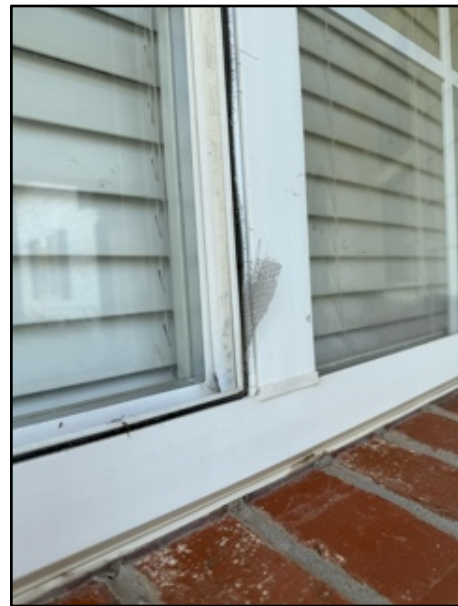
Multiple window screens were damaged or missing. Recommend repair or replace where needed.

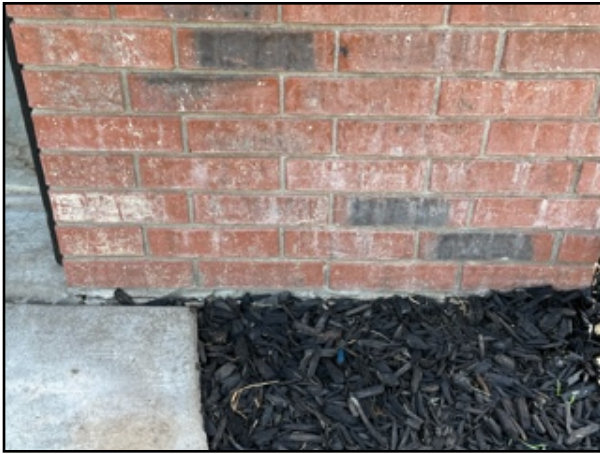
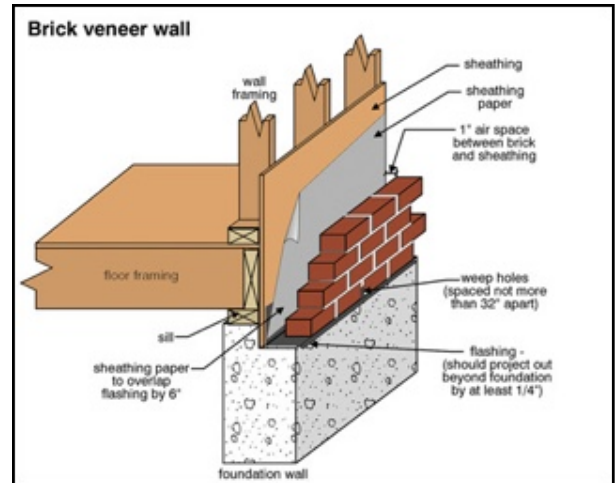
There were no weep holes installed in the masonry siding to allow trapped moisture to drain away. The inspector recommends having a qualified masonry professional install weep holes as needed.

(This is a common issue in Wichita and surrounding areas.)

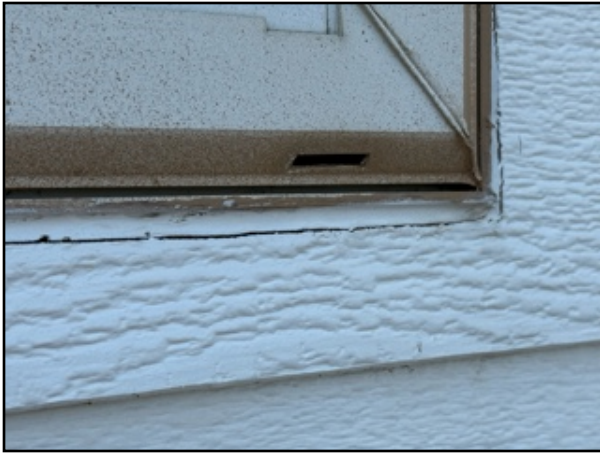
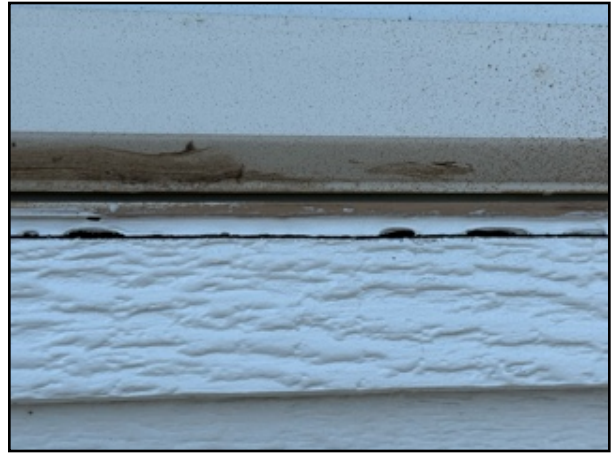
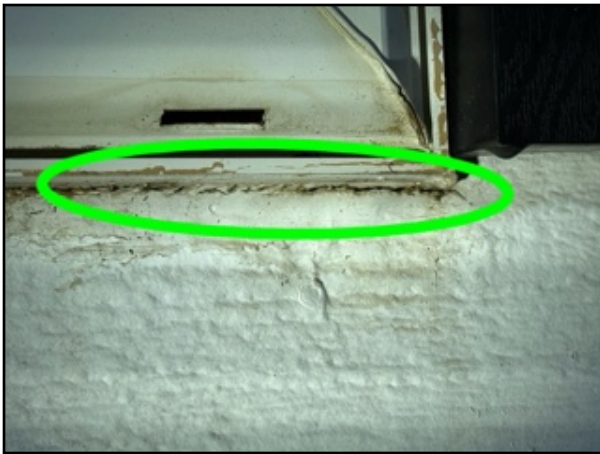
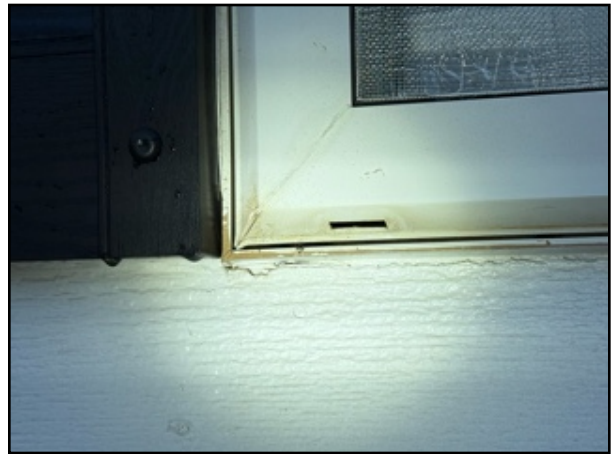
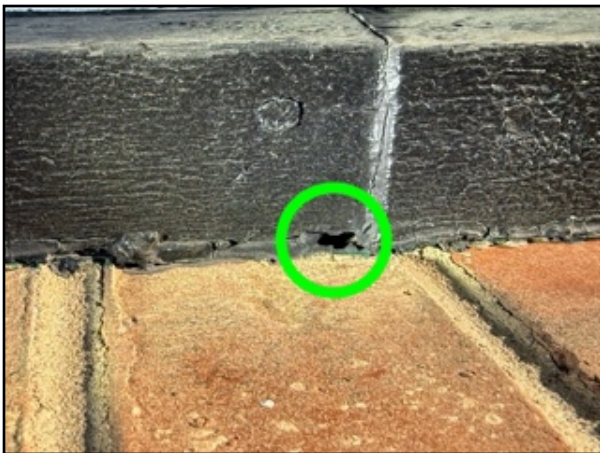
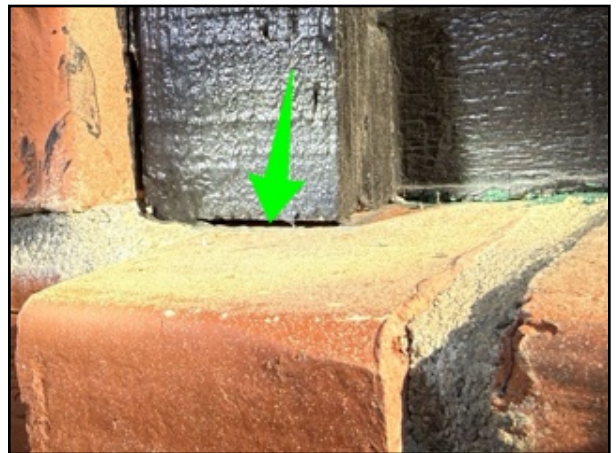
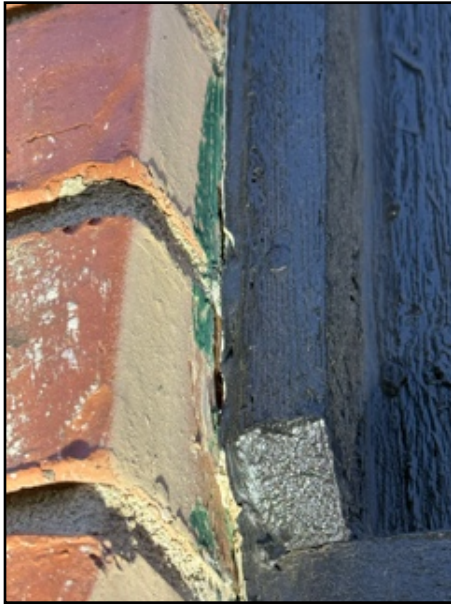
The caulking/sealant around the windows, siding & trim of the home needed maintenance at the time of the inspection. Have all work performed by a qualified professional.

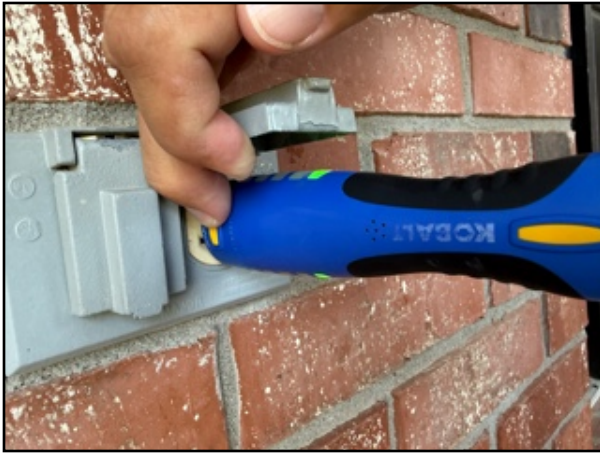
Figure 10-1

2) Comment 10: One or more exterior electric receptacles were not GFCI protected. The inspector recommends repair by a licensed electrician where necessary.

One or more exterior electric receptacles were not GFCI protected. The inspector recommends repair by a licensed electrician where necessary.

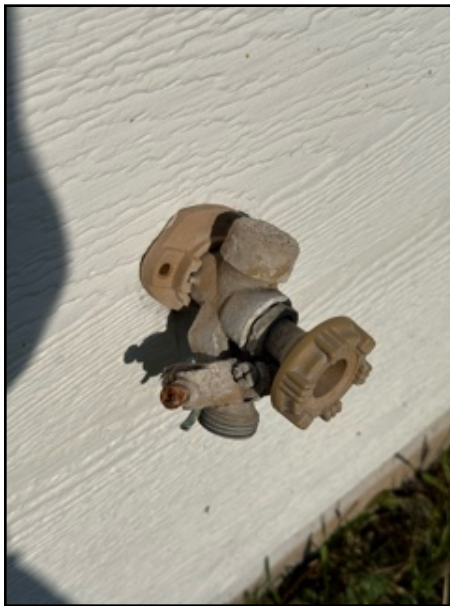
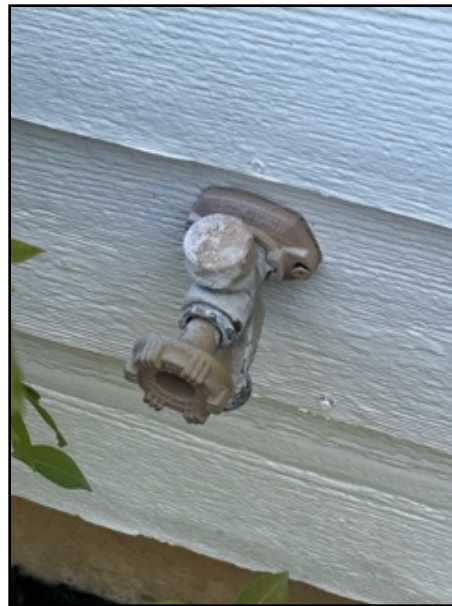
The exterior hose bibs were not secured to the home at the time of the inspection.

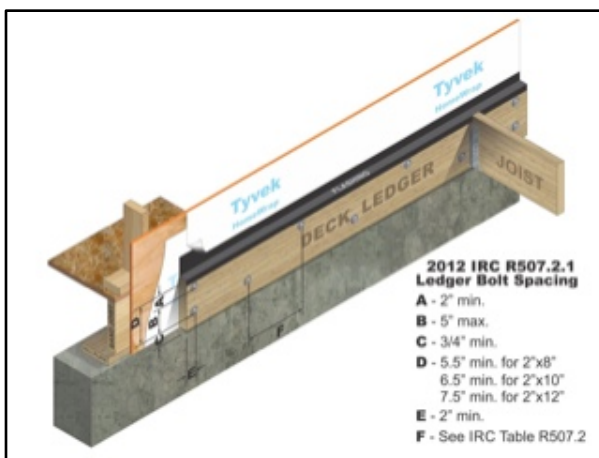
Figure 12-1

3) Comment 12: The deck was attached to the home with a ledger board that was not flashed properly. This can trap moisture and cause wood rot on the back side of the ledger board. The inspector recommends evaluation and repair by a qualified contractor.

The deck was attached to the home with a ledger board that was not flashed properly. This can trap moisture and cause wood rot on the back side of the ledger board. The inspector recommends evaluation and repair by a qualified contractor.

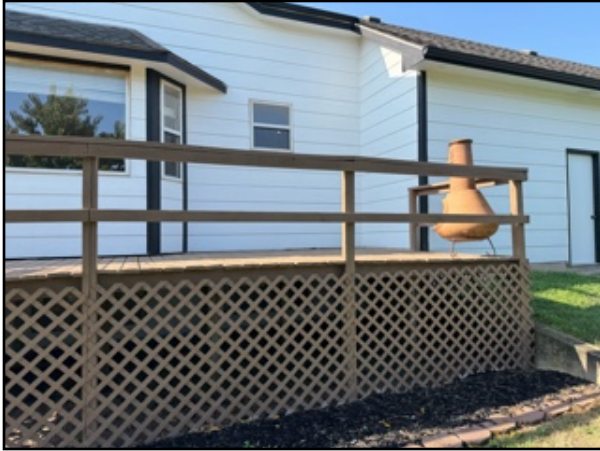
Figure 13-1

Posts supporting deck guardrail assemblies were placed too far apart. The over-spanned guardrail assemblies appeared to be structurally inadequate as fall protection. The Inspector recommends correction by a qualified contractor.

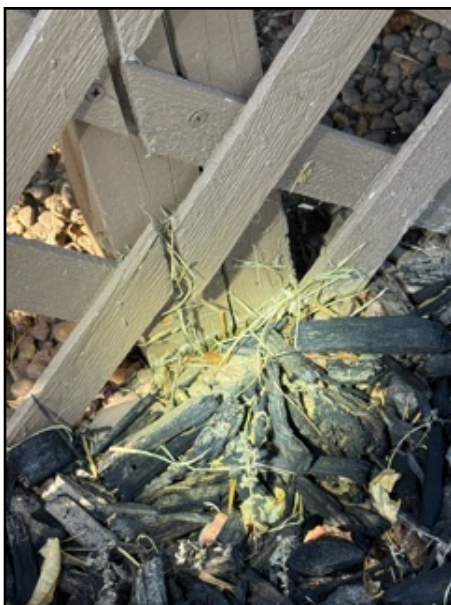
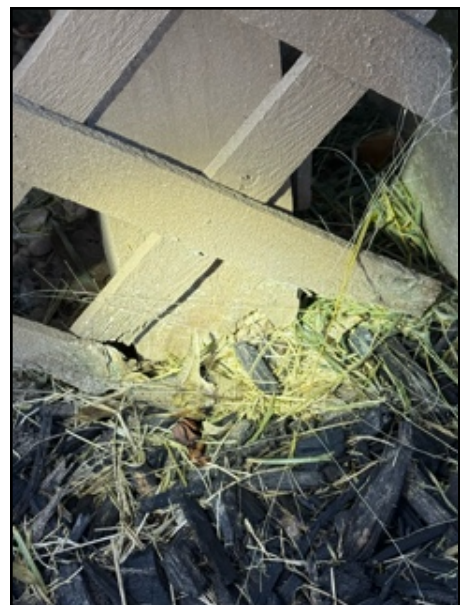
4) Comment 14: Foundation piers for deck support posts were not present or did not extend high enough above grade to prevent wood post contact with soil. This condition will cause eventual decay of post bases. The Inspector recommends correction by a qualified contractor.

Foundation piers for deck support posts were not present or did not extend high enough above grade to prevent wood post contact with soil. This condition will cause eventual decay of post bases. The Inspector recommends correction by a qualified contractor.

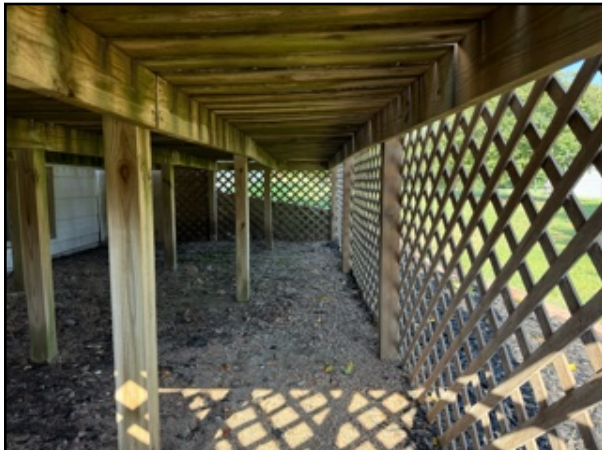
Figure 15-1

The deck was built with 4x4 support posts which are no longer allowed because of the tendency to twist, warp & split. These should be monitored over time for changes, or replaced with 6x6 posts.

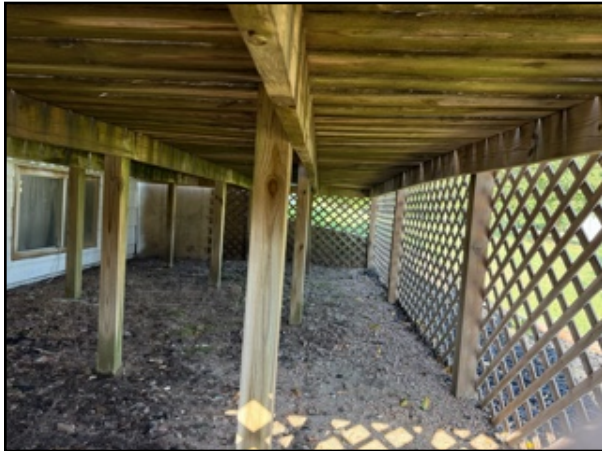
Figure 16-1

5) Comment 16: The deck had unconventional framing practices and had experienced some settlement and movement. The joists were over-spanned, were in the wrong orientation and had no joist hangers or band joist. This should be further evaluated by a qualified contractor to determine options and costs for any necessary repairs.

The deck had unconventional framing practices and had experienced some settlement and movement. The joists were over-spanned, were in the wrong orientation and had no joist hangers or band joist. This should be further evaluated by a qualified contractor to determine options and costs for any necessary repairs.

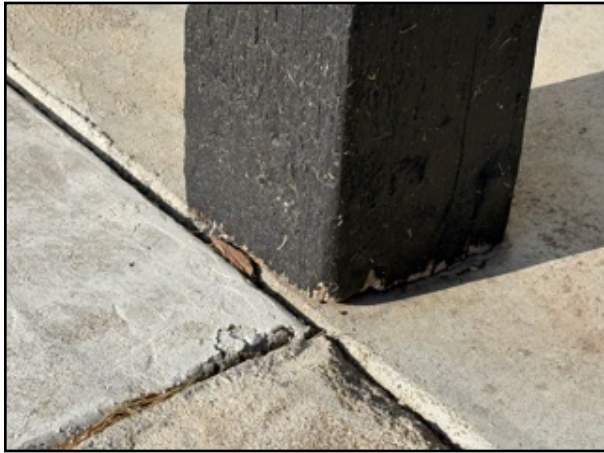
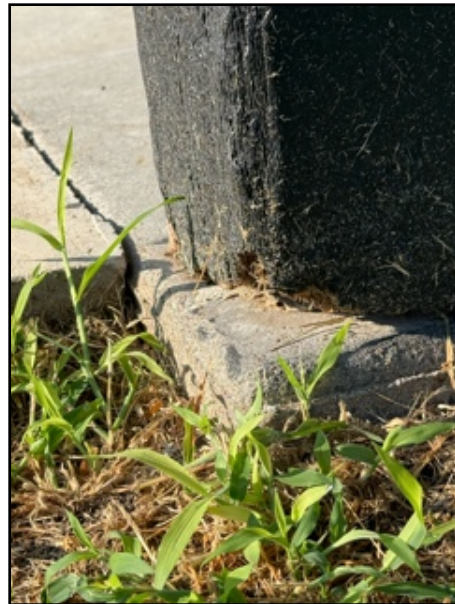
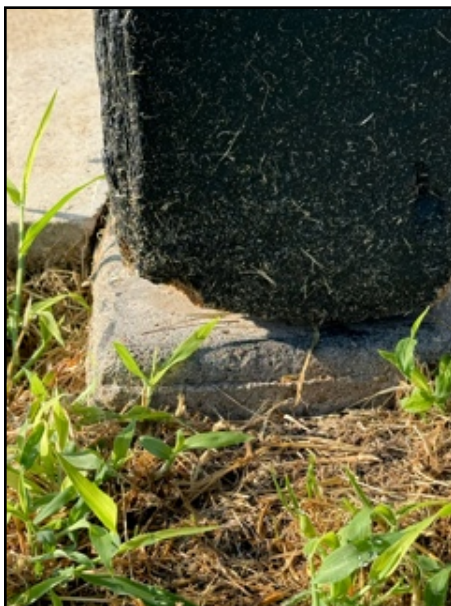
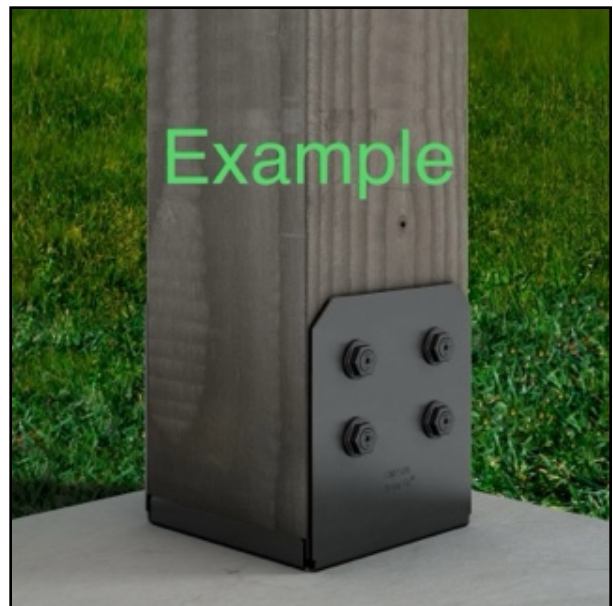
6) Comment 17: Support posts for the back patio overhang were not resting on metal post bases which has caused deterioration to the bottom of the posts. The inspector recommends having a qualified contractor install metal post bases as needed.

Support posts for the back patio overhang were not resting on metal post bases which has caused deterioration to the bottom of the posts. The inspector recommends having a qualified contractor install metal post bases as needed.

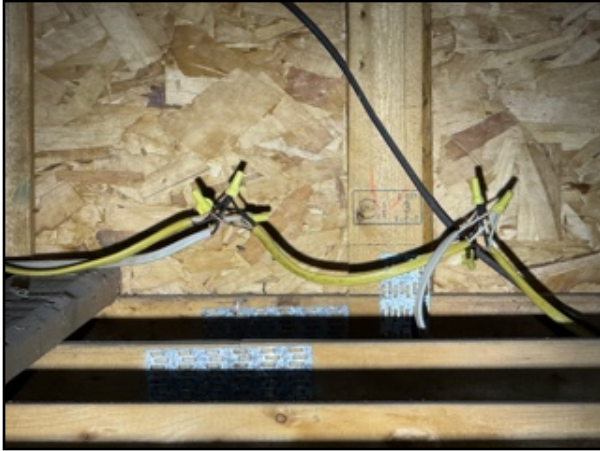
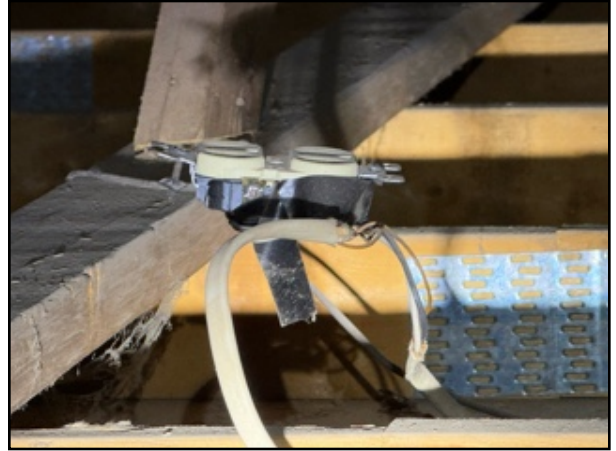
Energized electrical splices not contained within a junction box and exposed to touch were visible in the attic at the time of the inspection. Electrical splices should be contained within a junction box with a cover plate installed.

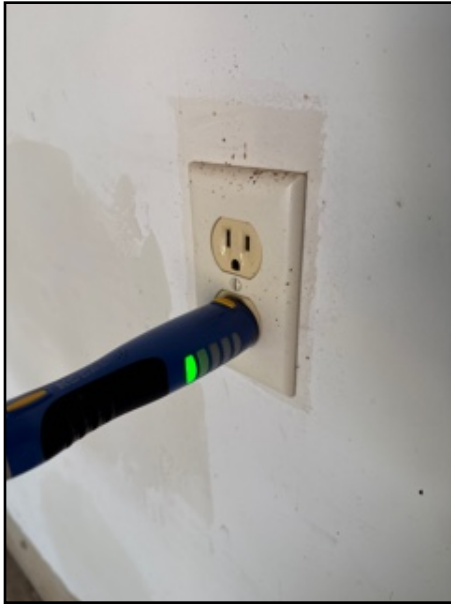
Figure 22-1

7) Comment 22: Electrical receptacles in the garage had no Ground Fault Circuit Interrupter (GFCI) protection or it would not trip. Although this was considered safe or acceptable at the time the home was originally constructed, building standards have changed. Consider having GFCI protection installed as a safety precaution.

Electrical receptacles in the garage had no Ground Fault Circuit Interrupter (GFCI) protection or it would not trip. Although this was considered safe or acceptable at the time the home was originally constructed, building standards have changed. Consider having GFCI protection installed as a safety precaution.

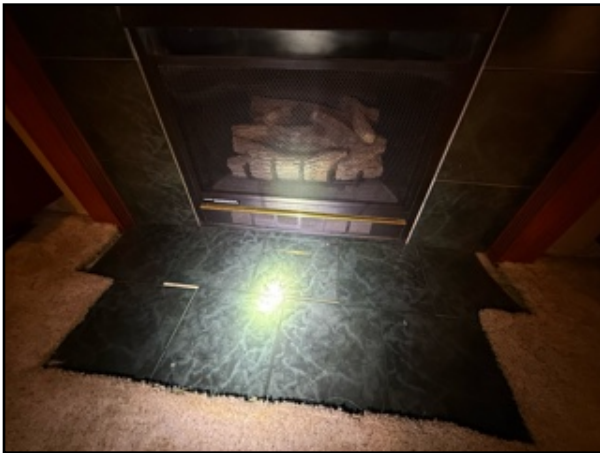
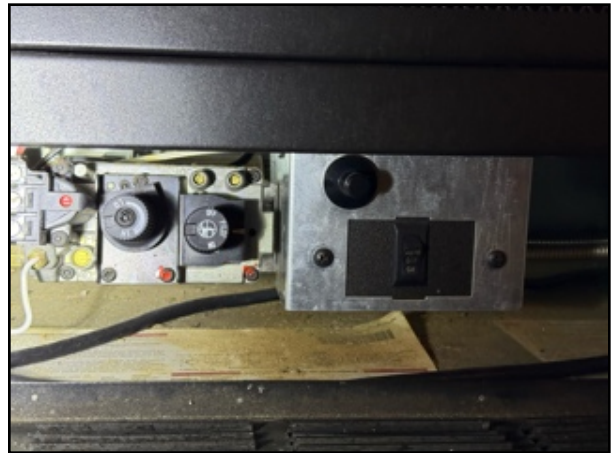
8) Comment 24: The inspector could not get the downstairs fireplace to light. This should be further evaluated by a qualified fireplace repair contractor.

The hearth extension also had tiles that were not secured and should be repaired.

The inspector could not get the downstairs fireplace to light. This should be further evaluated by a qualified fireplace repair contractor.

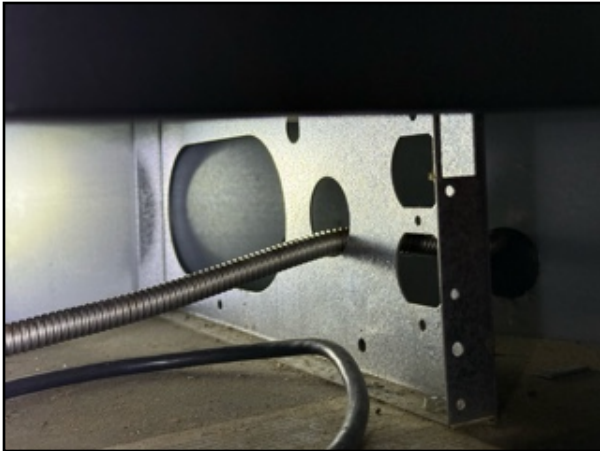
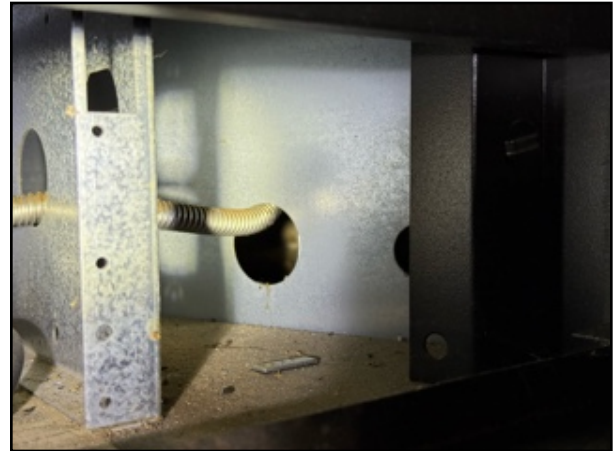
9) Comment 25: A flexible gas line was observed routed through the metal fireplace box. This installation can expose the gas line to physical damage, creating a potential safety hazard. A qualified HVAC or gas contractor should evaluate and correct as needed for safe operation.

A flexible gas line was observed routed through the metal fireplace box. This installation can expose the gas line to physical damage, creating a potential safety hazard. A qualified HVAC or gas contractor should evaluate and correct as needed for safe operation.

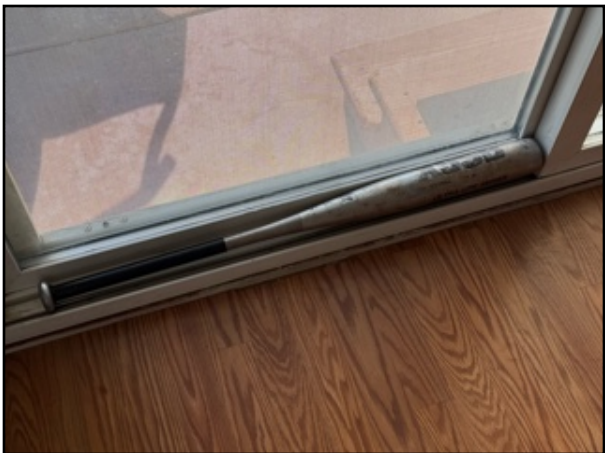
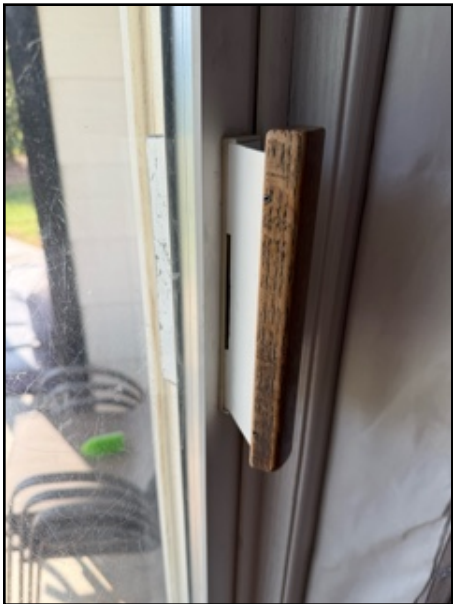
10) Comment 26: The rear sliding door did not lock and was held shut by a baseball bat. This should be evaluated and repaired by a licensed contractor.

~~The rear sliding door did not lock and was held shut by a baseball bat. This should be evaluated and repaired by a licensed contractor.~~

**FIXED**

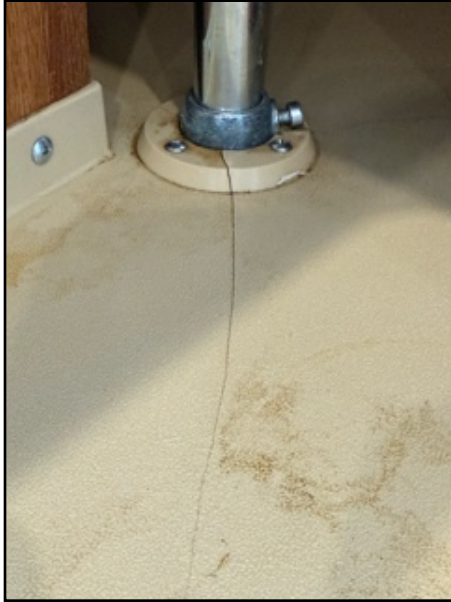
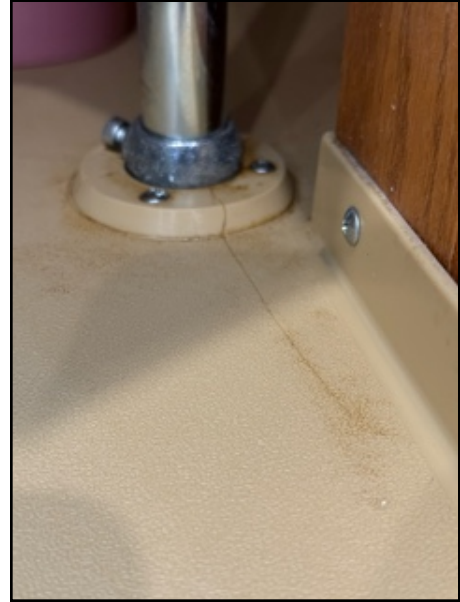
The "lazy Susan" corner rotating cabinet had a cracked shelf that should be replaced.

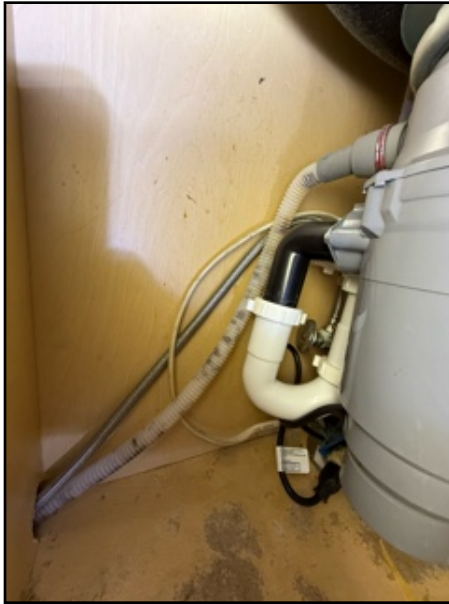
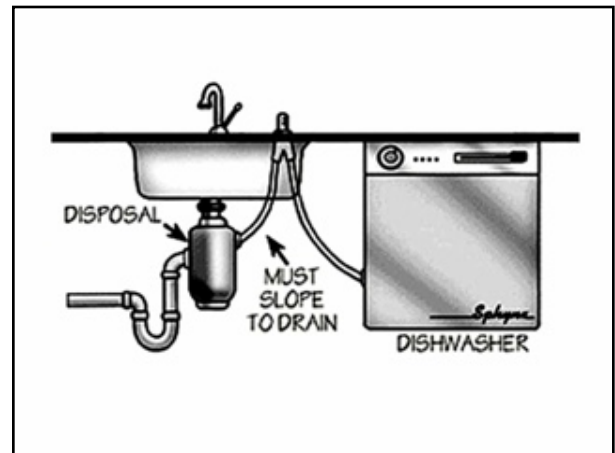
The dishwasher drain line was improperly configured and may experience problems related to siphoning. The drain line should attach to the underside of countertop or have an air gap device installed. Some newer dishwashers have this loop built into the side, but this is not visible to the inspector.

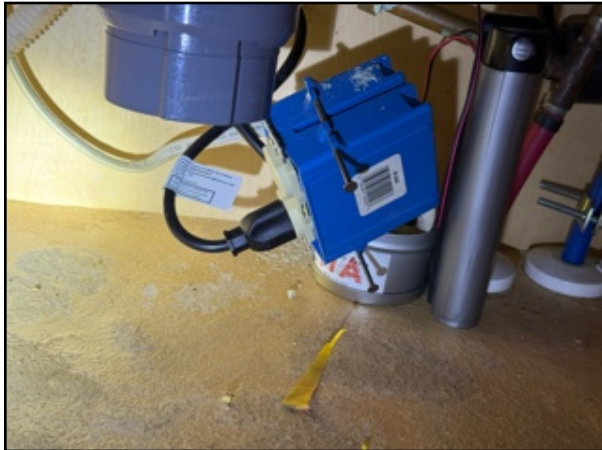
Figure 31-1

The electric receptacle beneath the sink was not secured and was hanging in the bottom of the cabinet. This should be secured by a qualified electrician.

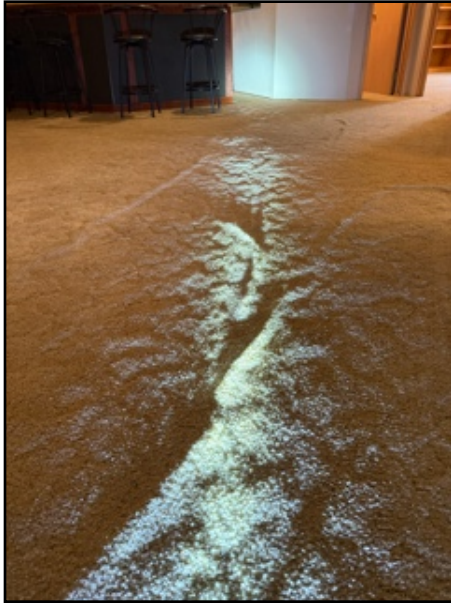
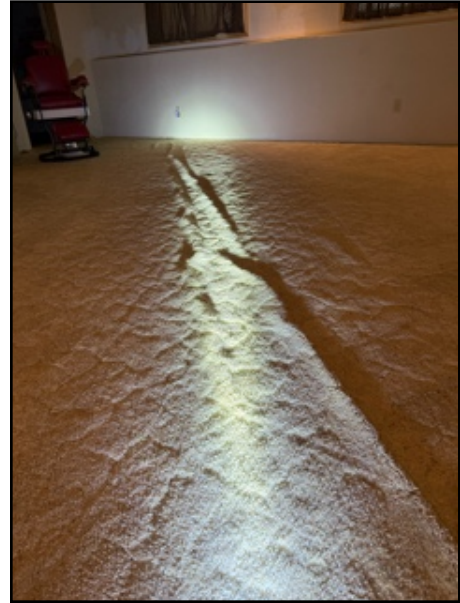
The carpet in this room needed to be stretched to prevent trip hazards.

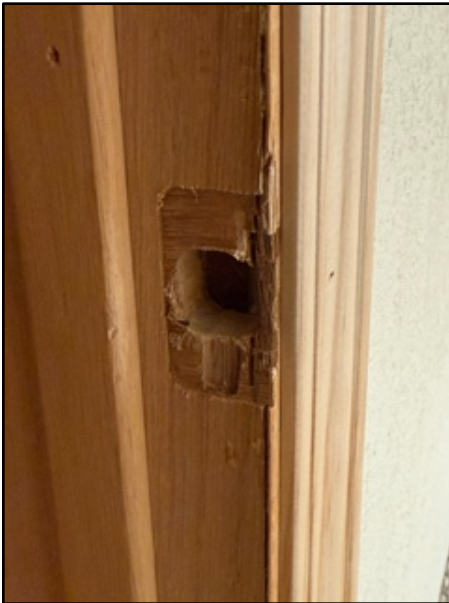
Figure 33-1

The door to this room was missing a throw plate.

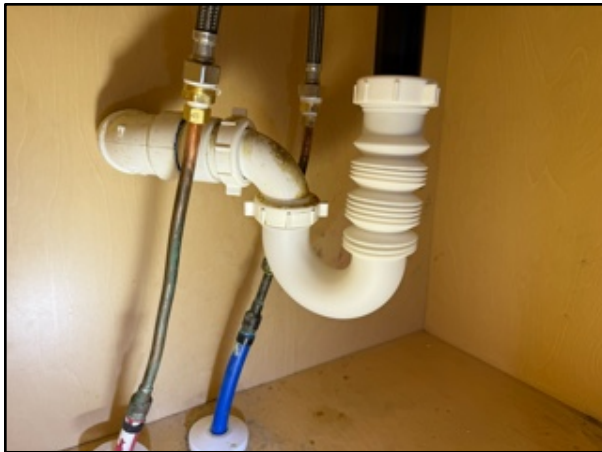
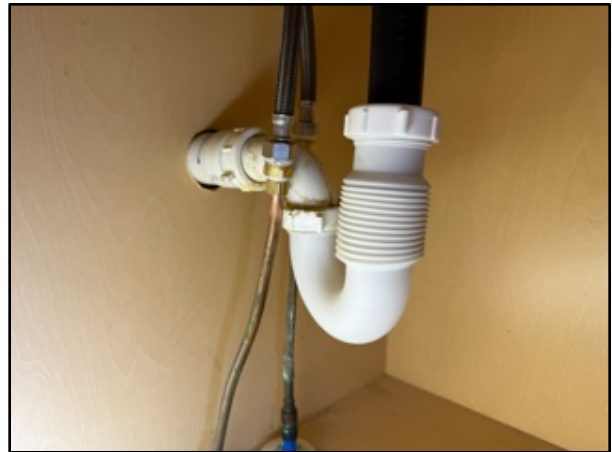
Flexible drain lines like the one used underneath this sink can sometimes hold debris and develop odors. Smooth-walled drain lines are best used for this purpose.

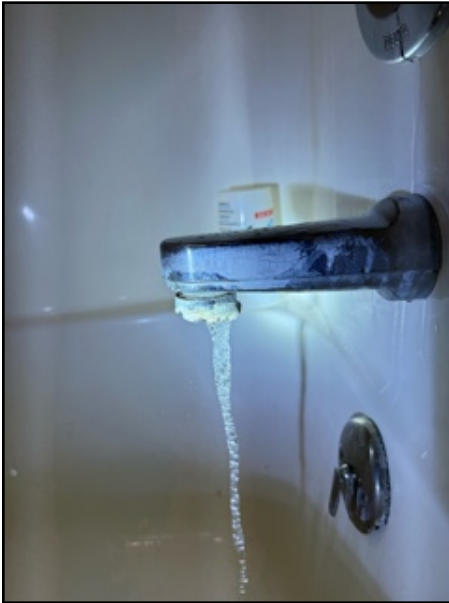
Figure 35-1

The diverter valve was inoperable or did not operate correctly (the diverter is the valve that diverts water from the tub faucet to the shower head). The Inspector recommends maintenance/repair be performed by a qualified contractor.

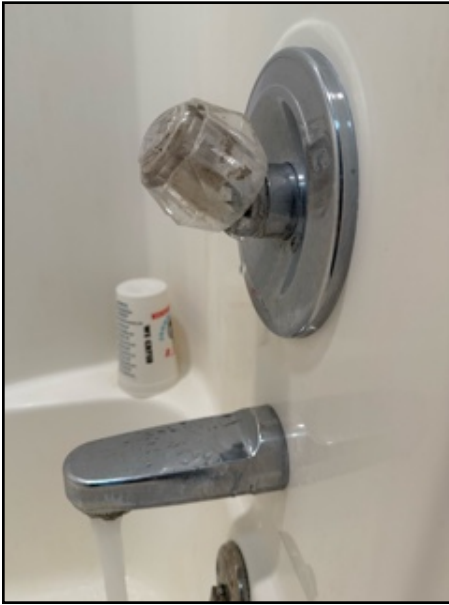
Figure 36-1

There was a slow leak from the water shut off in the bathtub that should be repaired.

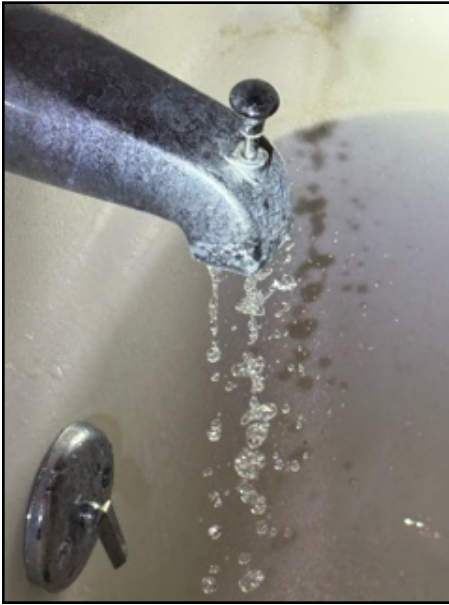
Figure 37-1

The diverter valve was inoperable or did not operate correctly (the diverter is the valve that diverts water from the tub faucet to the shower head). The Inspector recommends maintenance/repair be performed by a qualified contractor.

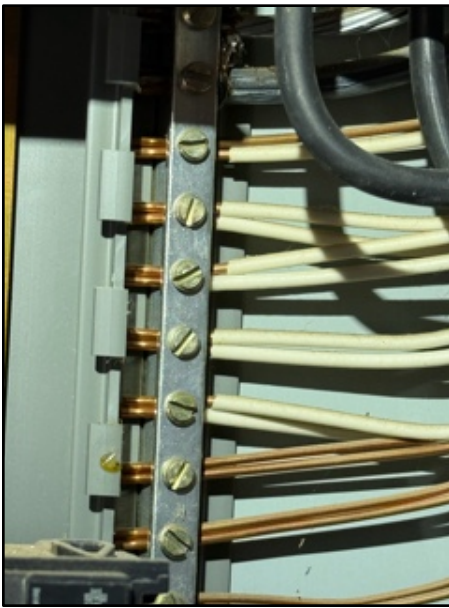
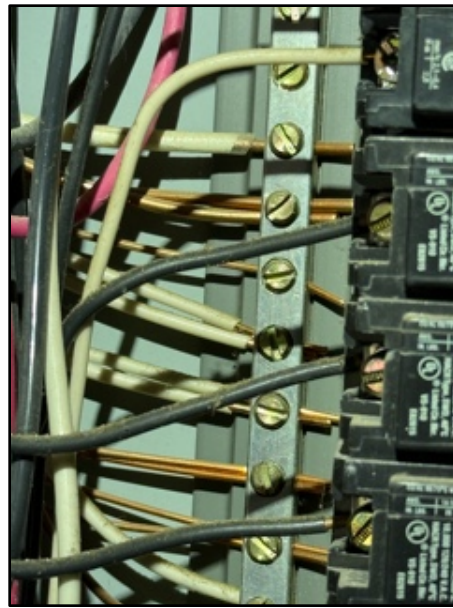
In the service panel, 2 or more neutral wires terminated under the same lug. This is improper. An individual terminal should be provided for each branch-circuit neutral conductor. Recommend repair by a licensed electrical contractor.

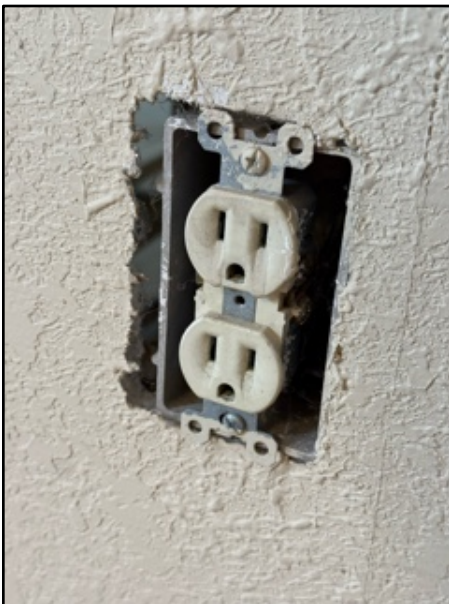
Figure 40-1

There were electric receptacles in various areas around the home without cover plates installed. These should be properly covered with new cover plates.

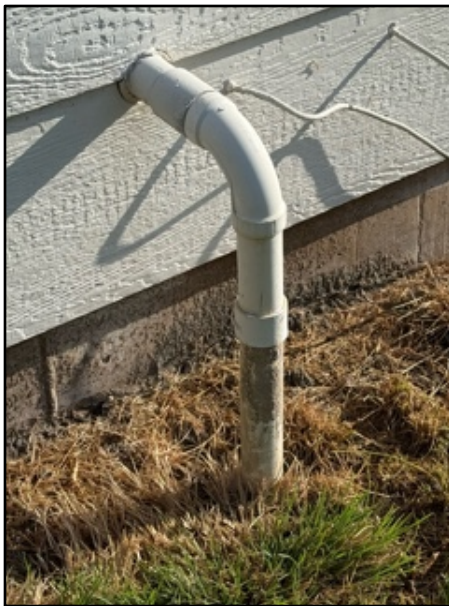
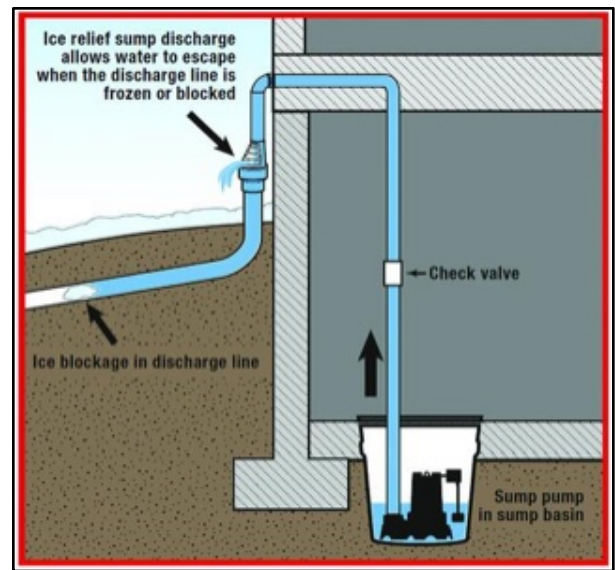
The sump pump discharge pipe routed underground without an air gap device installed. This is improper and can lead to pump damage in the event of an ice blockage within the discharge pipe. This should be corrected by a qualified plumber.

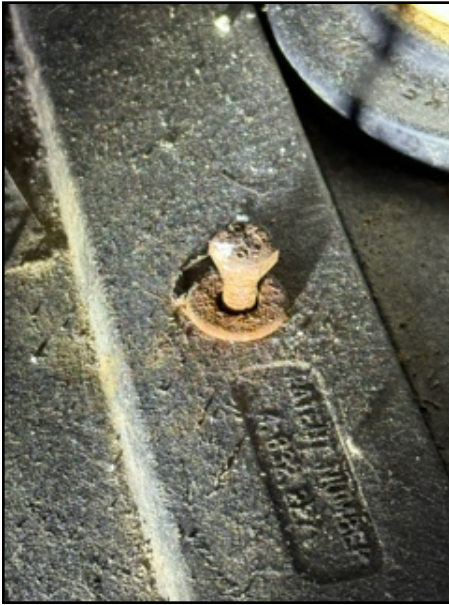
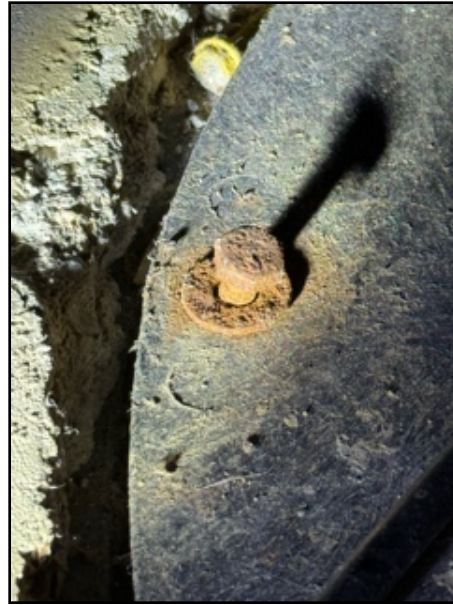
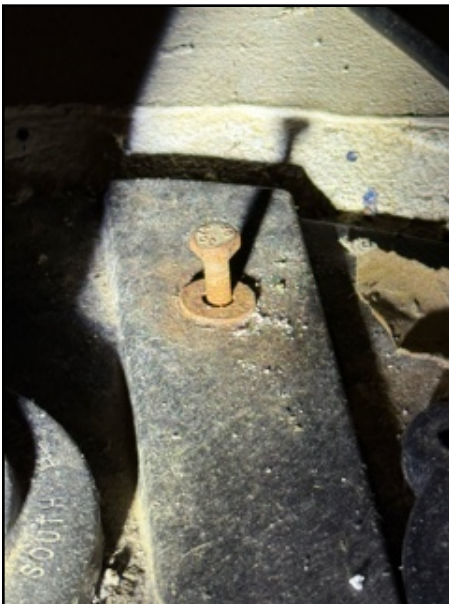
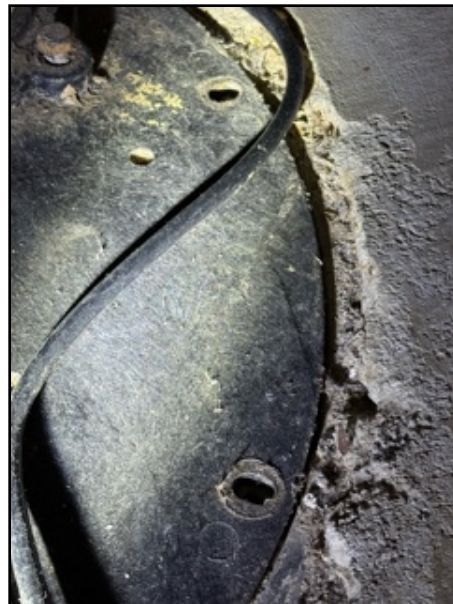
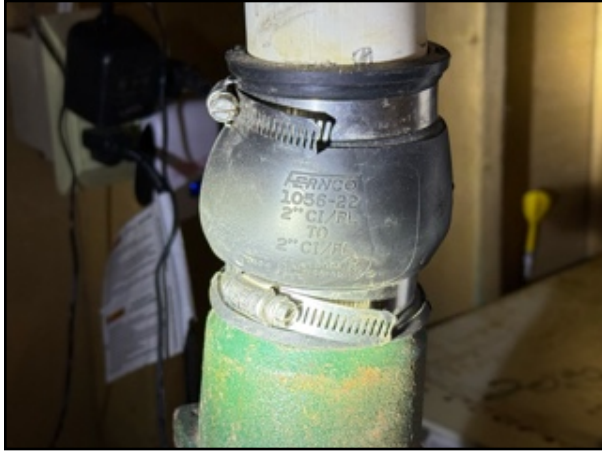
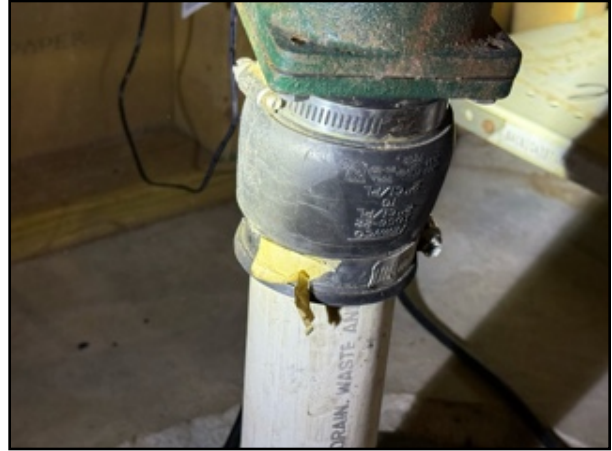
11) Comment 43: There were loose or missing fasteners and stretched couplings for the sewage ejector pump. The inspector recommends having a licensed plumber to evaluate and repair the ejector pump and pipe system as needed.

There were loose or missing fasteners and stretched couplings for the sewage ejector pump. The inspector recommends having a licensed plumber to evaluate and repair the ejector pump and pipe system as needed.

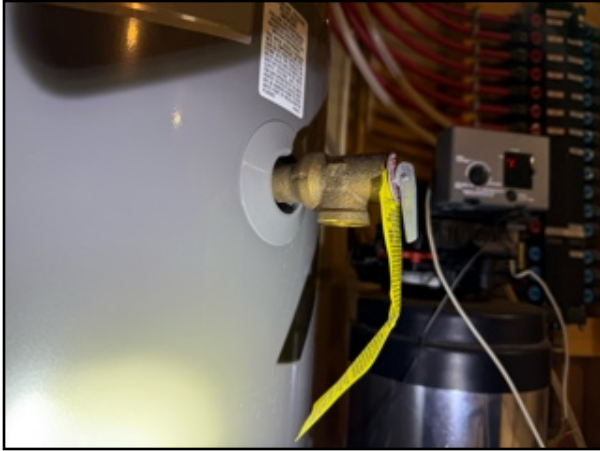
Figure 44-1

12) Comment 44: The water heater temperature/pressure relief (TPR) valve had no discharge pipe installed. The Inspector recommends that a properly-configured TPR discharge pipe be installed by a qualified plumbing contractor.

The water heater temperature/pressure relief (TPR) valve had no discharge pipe installed. The Inspector recommends that a properly-configured TPR discharge pipe be installed by a qualified plumbing contractor.

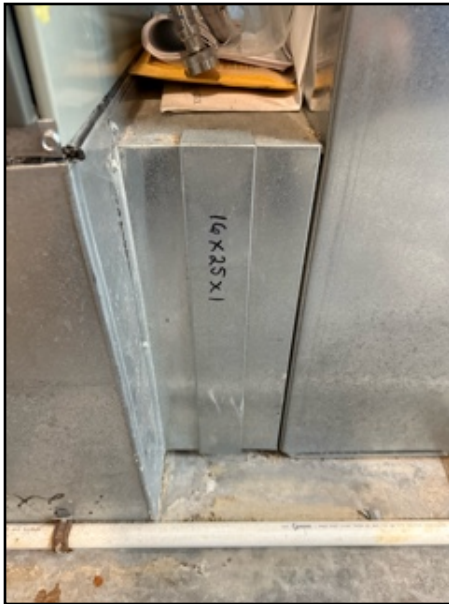
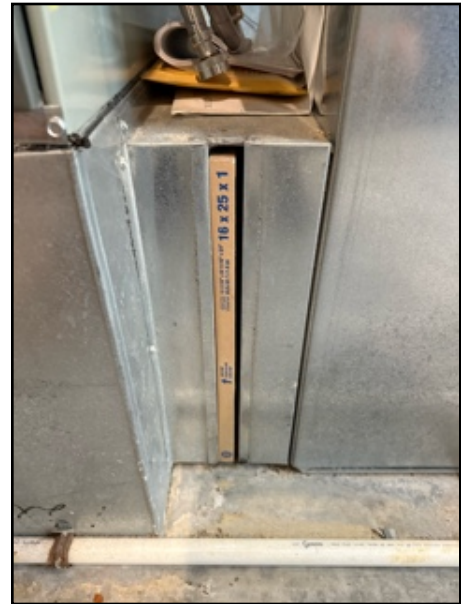
Comment 46:  
Filter location.

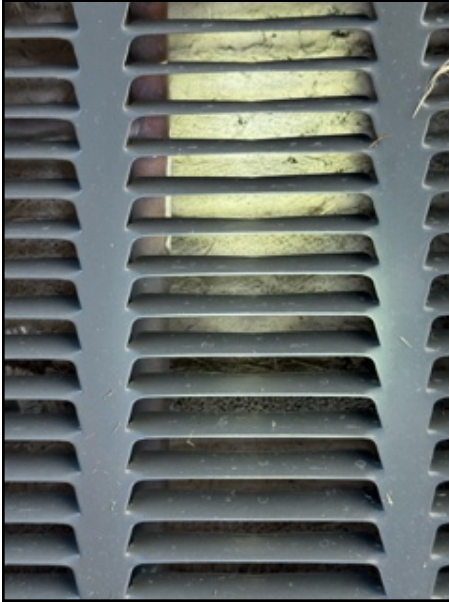
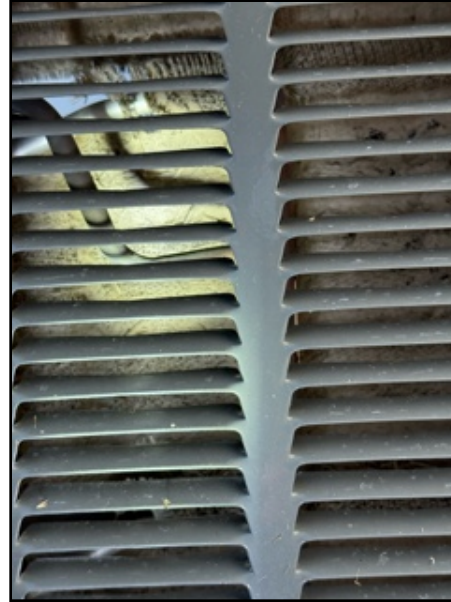
Airflow to the air-conditioner compressor unit coils was restricted by dirt and/or debris on the exterior which may limit the system ability to dissipate heat. The cabinet should be cleaned in order to maintain cooling system efficiency and avoid problems from overheating of the compressor. The inspector recommends having the unit serviced by a qualified professional.
