INVOICE

Regarding: 4307 S. Hickory Pl., Broken Arrow
AEI Reference: 2506191

On Wednesday, June 18, 2025, AEI Group, P.L.L.P., (AEI), conducted an initial visual examination at the address referenced above.

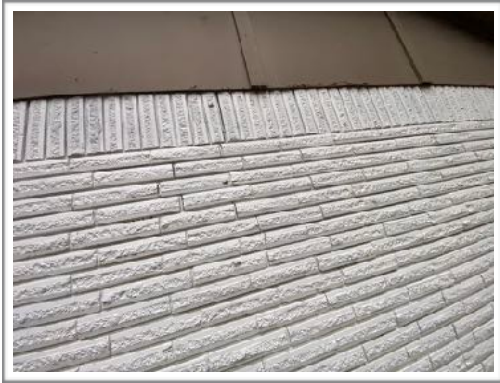
There are veneer cracks (1/4" or larger) and stem wall cracks and separations on the south and southeast corners of the garage. These cracks and separations are indications of foundation movement.

Exterior veneer crack on the south side of the garage

In our opinion, underpinning is necessary to extend the foundation support to depths that provide greater bearing capacity and/or are less affected by climate, soil conditions and/or homeowner's actions.

- Underpin the perimeter footings with Three (3) exterior piers. See attached drawings, details and specifications. After underpinning, cosmetically repair any remaining gaps and separations by tuck pointing or epoxy grouting.
- The plumbing system under the slab (both supply and sewer) shall be pressure tested and the result to be presented in a report from qualified licensed plumbing contractor. If there is no leak then the interior sheet rock cracks should be repaired and then monitored. In the case that there is plumbing leak under the slab the area should be evaluated during the repair of the plumbing and further recommendation to be given.
- At this time, no other structural action is recommended beyond ordinary homeowner maintenance and monitoring. Any evidence of floor settlement or occurrence of cracks should be evaluated by a licensed Professional Engineer.

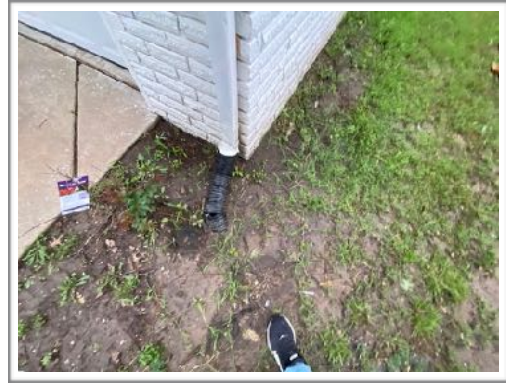
Existing gutter drain

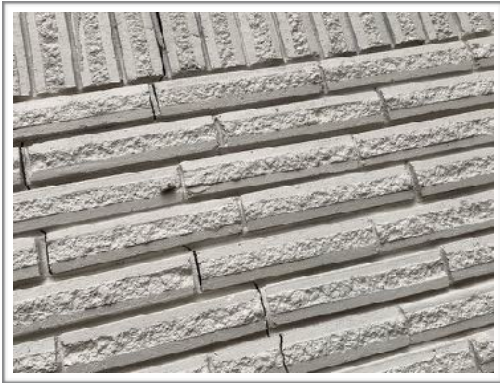
Exterior veneer crack on the south side of the garage

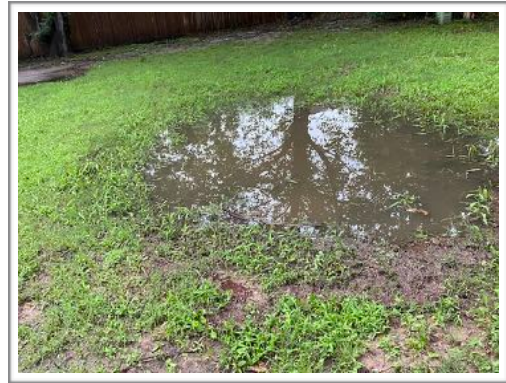
Standing water on the east side of the property

It is extremely important, particularly in areas of expansive soils, that water drains away from the foundation and not be allowed to pond against or near the foundation. The soil around the foundation should be graded to an obvious slope (two to five percent). Fill in any low spots with select fill (sandy clay) and level any high spots.

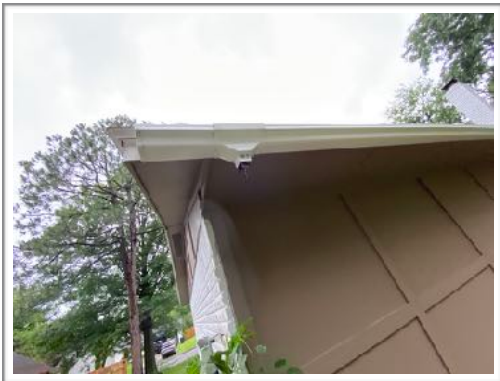
Missing down spout

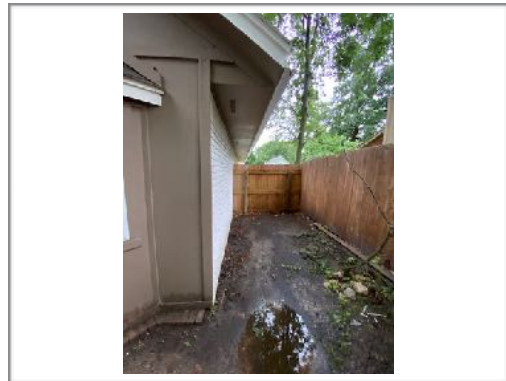
Standing water and missing down spout

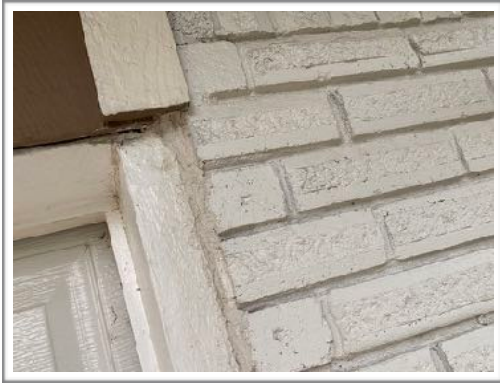
Sealed veneer separation on the southwest corner the garage

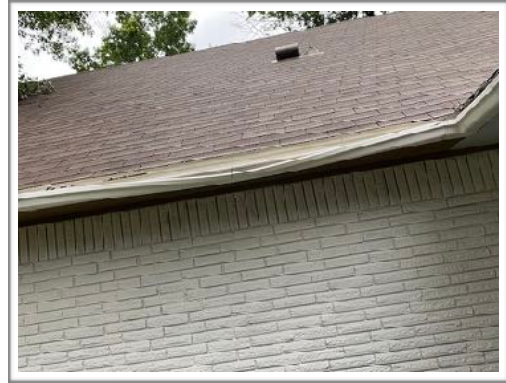
Damaged gutter

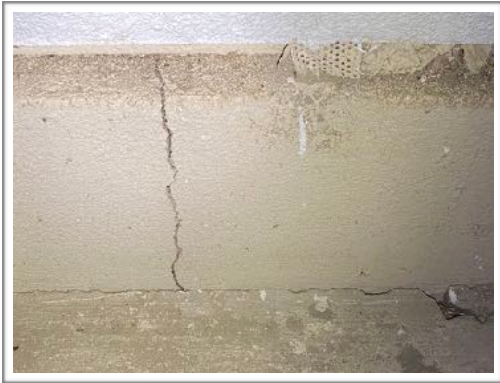
Stem wall crack

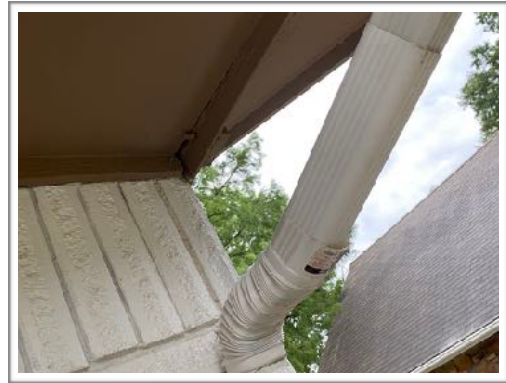
Trim separations

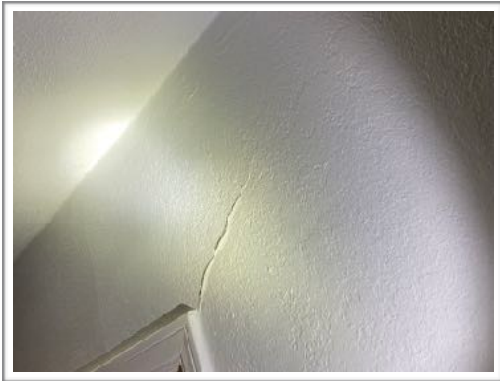
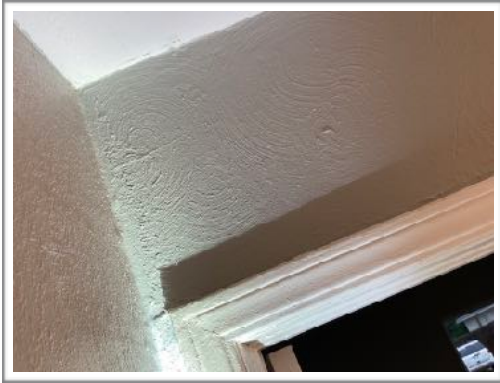
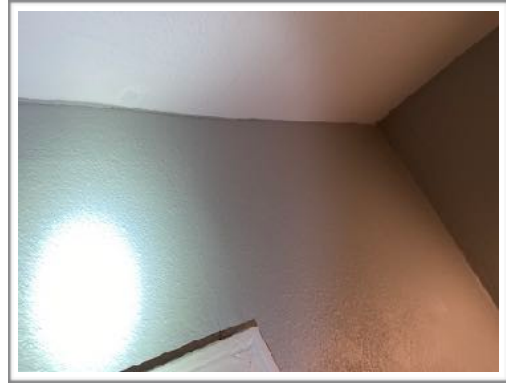
There are repaired drywall cracks evidence of possible plumbing leak under the slab of the structure. When a plumbing leak occurs under a slab, the moisture equilibrium is distorted. As moisture is added to the soil from the leak, soil and foundation movement often result. The type and degree of movement depends upon soil type and expansiveness, soil density, soil moisture content prior to the leak, the length of time over which the leak has occurred, the quantity of moisture being added to the soil over a given period of time and a few other factors (site-specific geotechnical data is unavailable and beyond the scope of this evaluation).

Repaired drywall crack

We recommend having a hydrostatic leak test (plumbing test) performed to ensure the absence of plumbing leak(s).

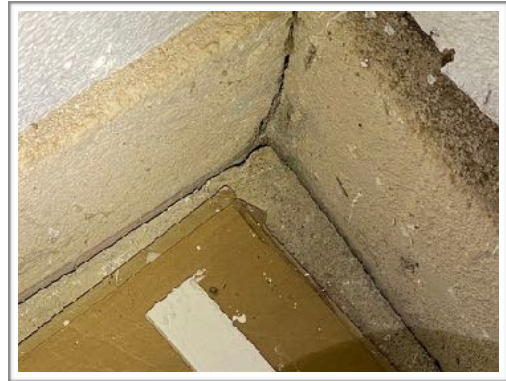
Stem wall crack and separation

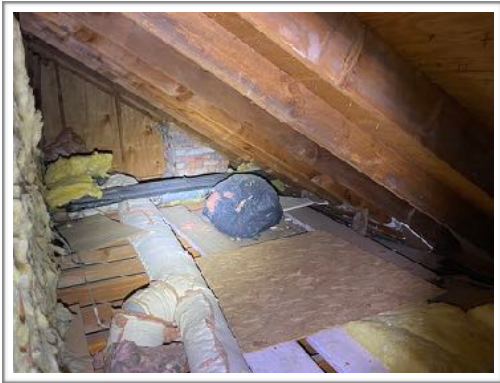
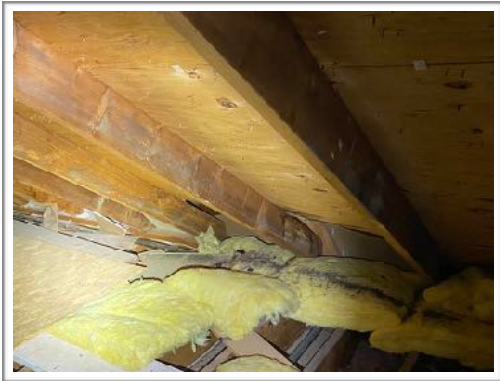
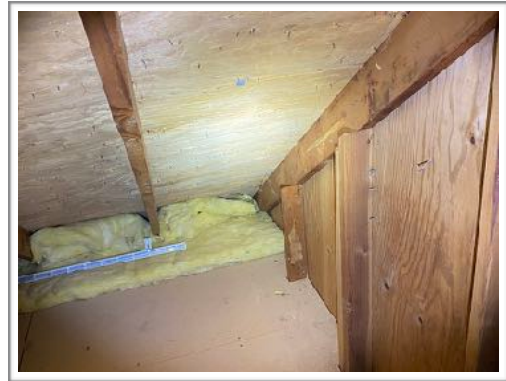
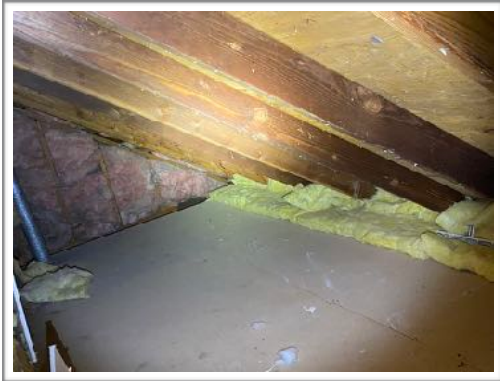
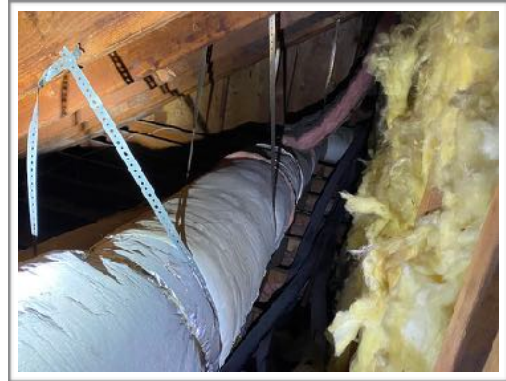
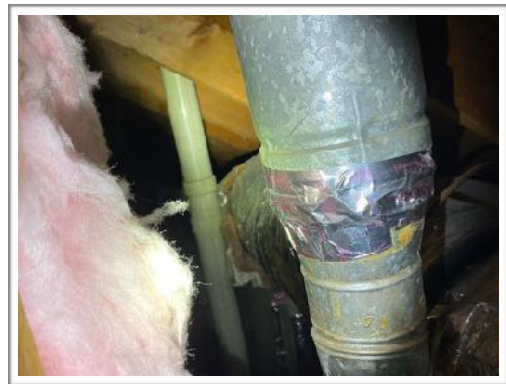
The visibility of the attic components and attic structure was limited due to either insulation, roof design, and/or access limitations. The main frame of the structure, including ceiling and roof members, appears to be in acceptable condition with no visible evidence of sagging or deflection(s).

Attic, Roof framing

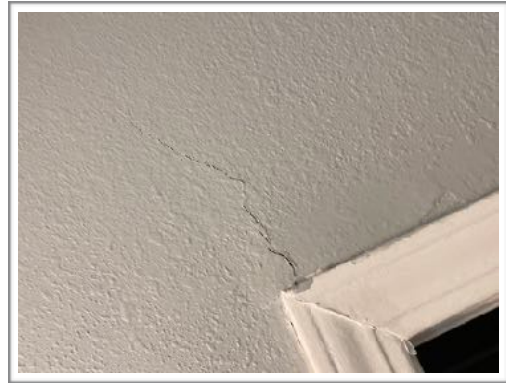
Drywall crack

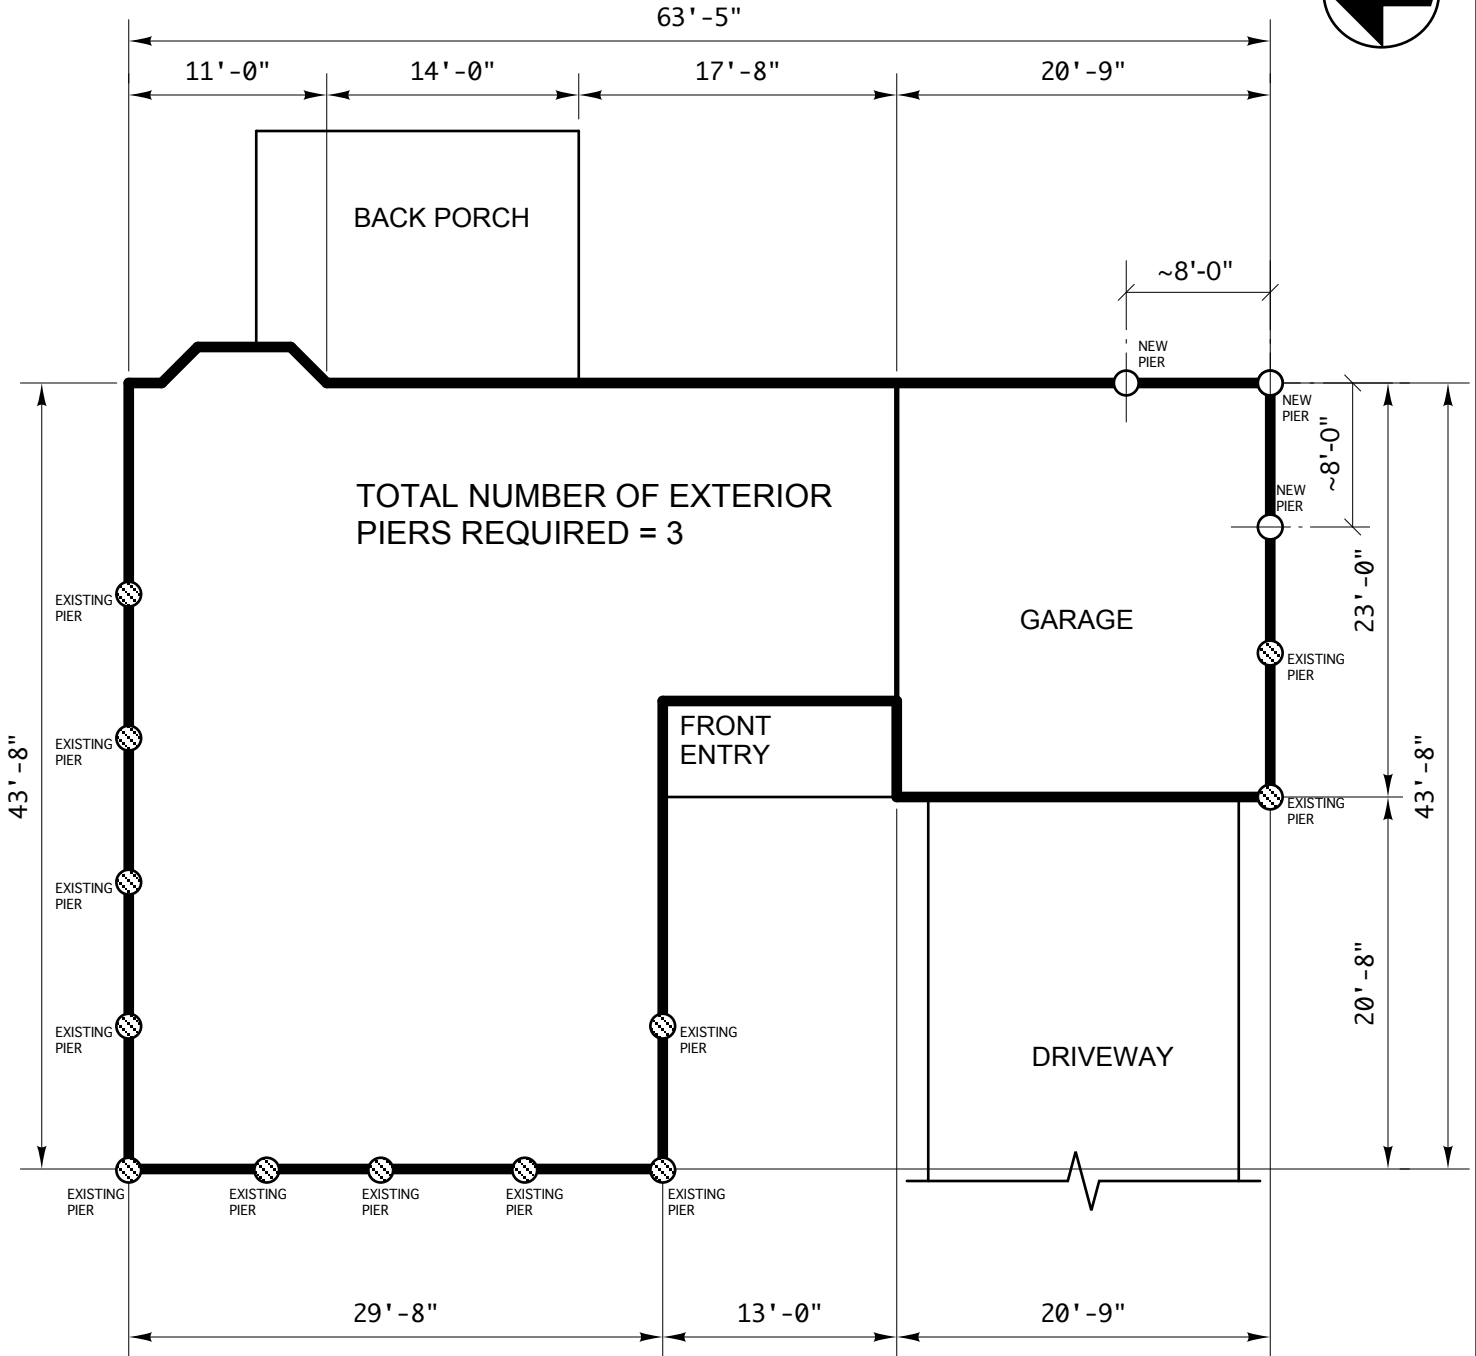
SK1

DESCRIPTION:
EXTERIOR
FOUNDATION REPAIR

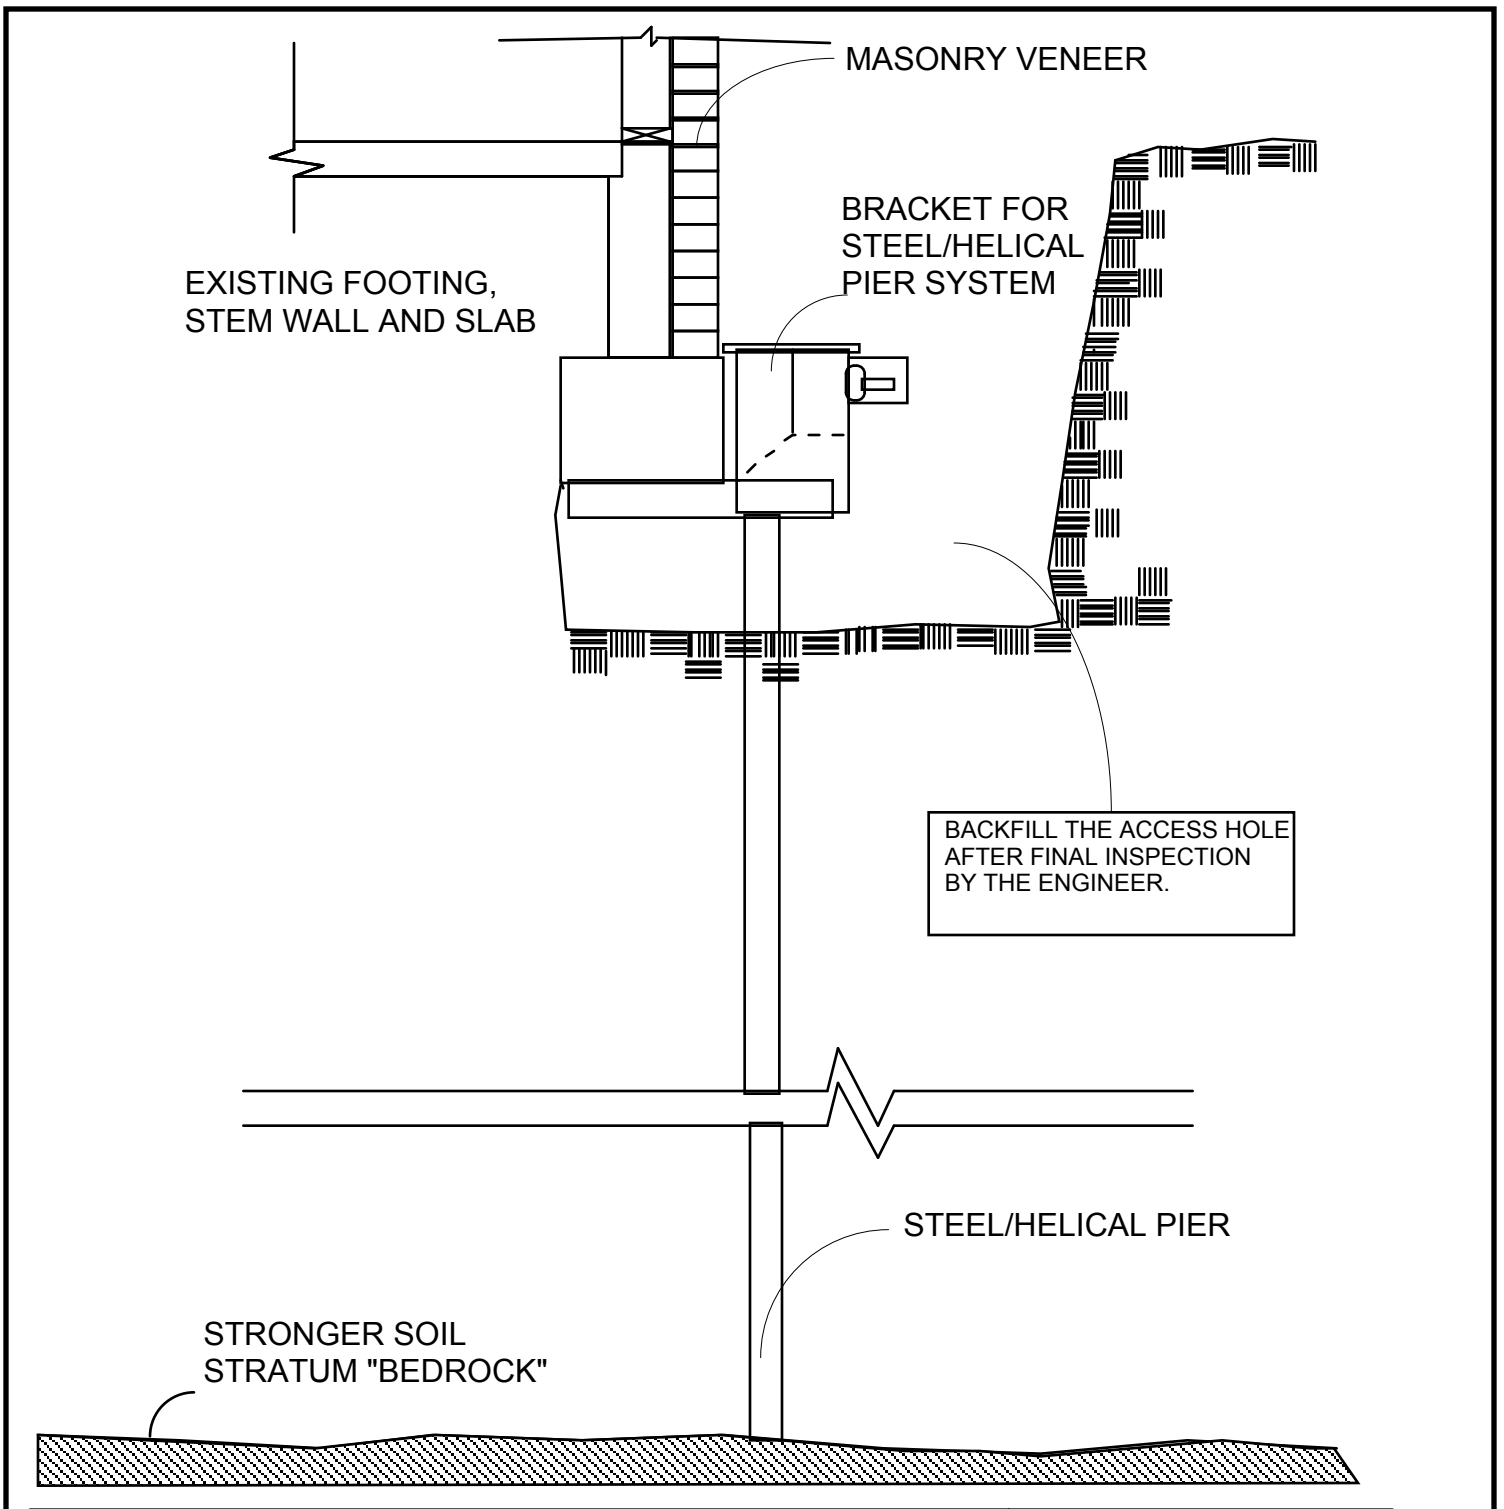
SK2

DESCRIPTION:
EXTERIOR STEEL/HELICAL
PIER DETAIL

- All piers should extend a minimum of 20' below existing grade unless approved by the engineer. Underpinning the existing spread footing foundation will change the load paths transferred to the earth. The loads by-pass the weak soil, clay or uncompacted soil and transfer the load directly to stronger strata "bedrock". The original footing becomes a beam spanning between piers. Therefore AEI's recommendation is to install piers so that they bear on stronger soil stratum such as bedrock and weathered shale.
