Brian Wert Inspection Agency, Inc.

Home Inspection Report

1434

105th Ave

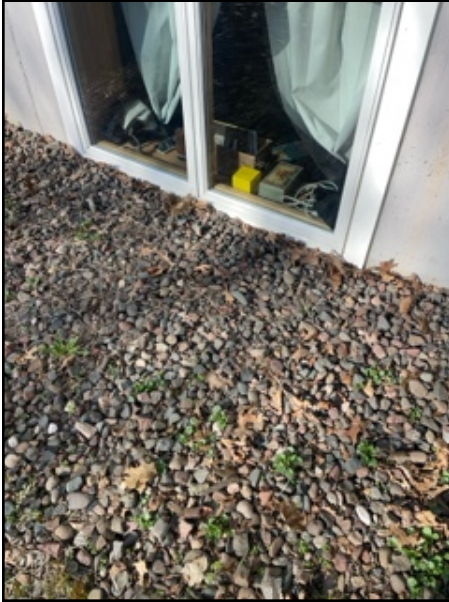
Figure 3-1

Comment 3:
Grade does not slope away from foundation.
Siding should be a minimum of 6" above grade.

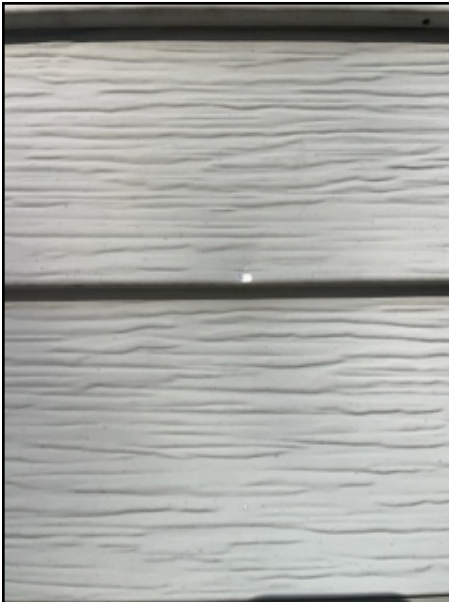
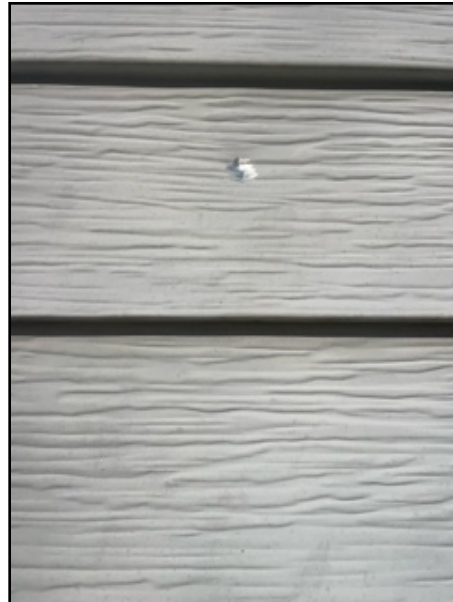
Comment 4:
Siding has minor damage.

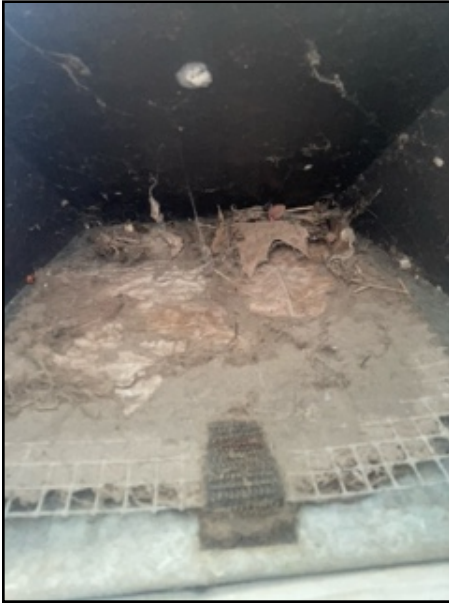
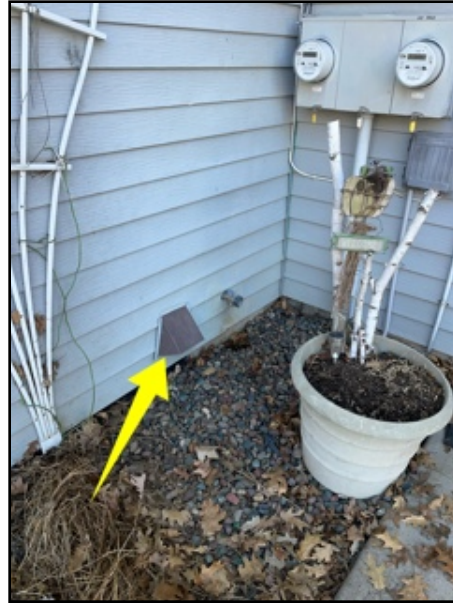
Comment 5:
Air intake should be cleaned.

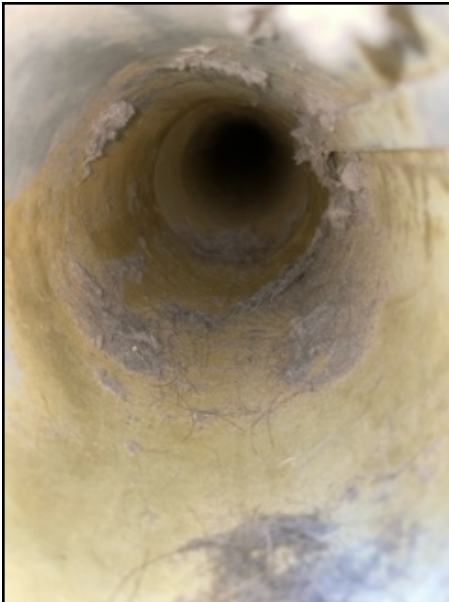
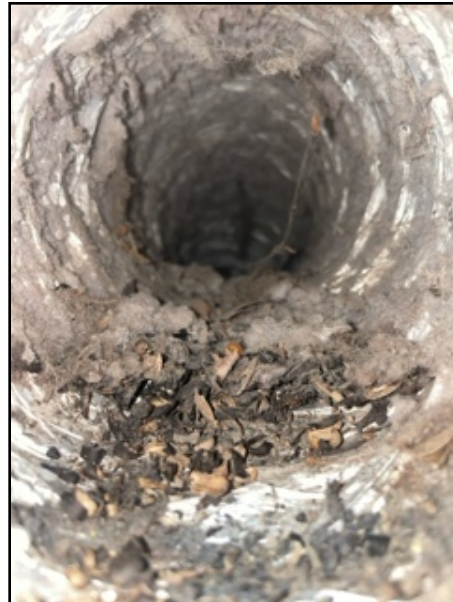
Comment 6:
Dryer vent.
Second picture is old vent

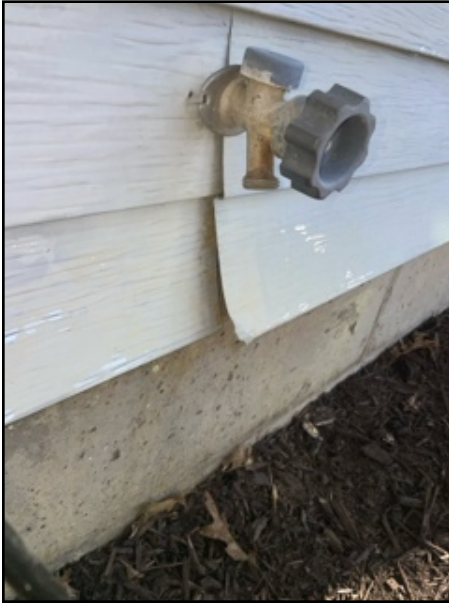
Figure 7-1

Comment 7:
Siding is loose by faucet.

2) Siding is loose by faucet.

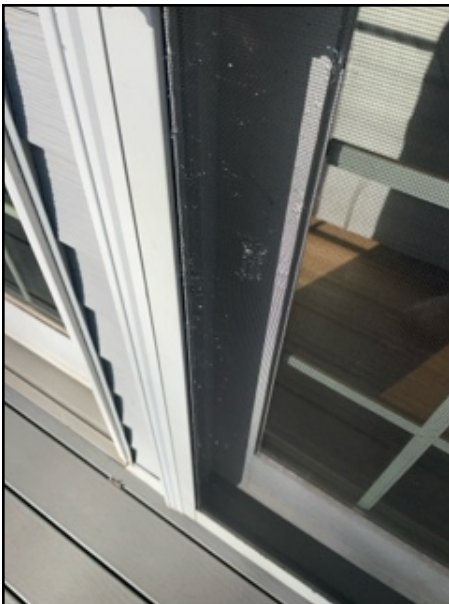
Figure 8-1

Comment 8:
Minor damage on patio screen.

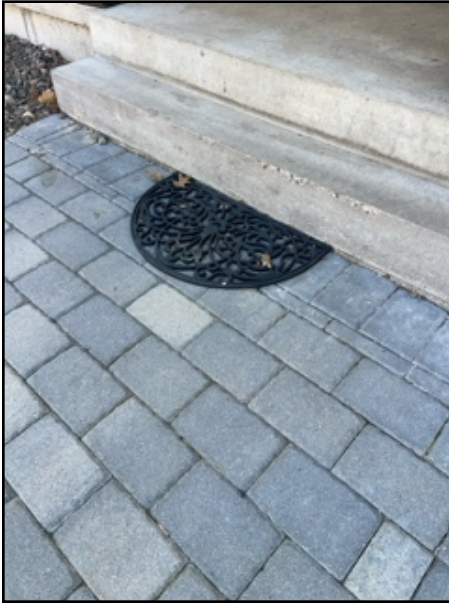
Figure 9-1

Comment 9:
Front sidewalk has sunk a little .

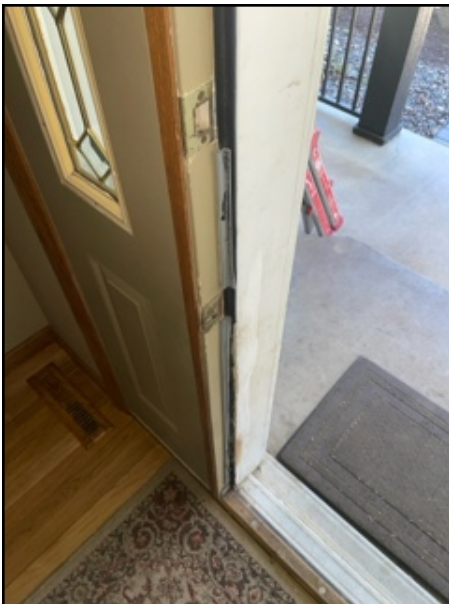
Figure 10-1

Comment 10:
Weatherstripping on front door is in poor condition .

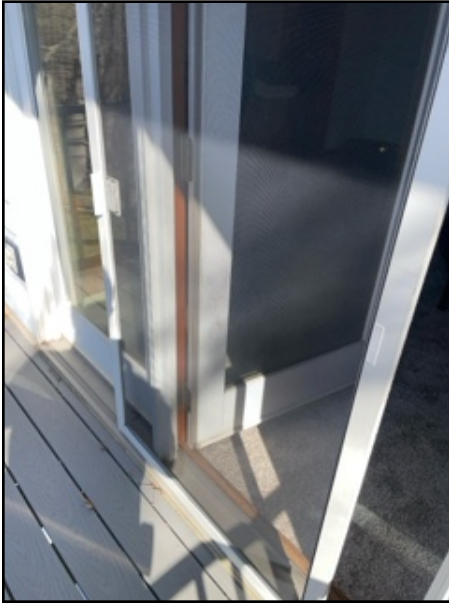
Figure 11-1

Handle on screen in master bedroom is backwards.

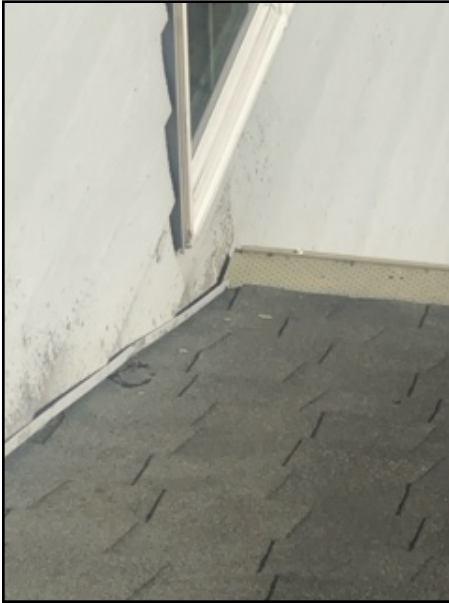
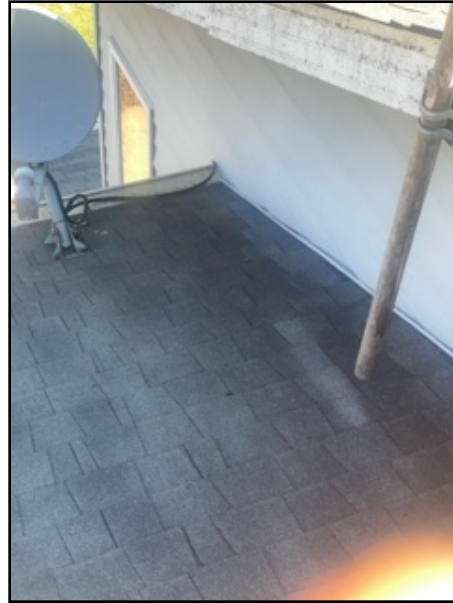
Comment 12:
No kick out flashing.

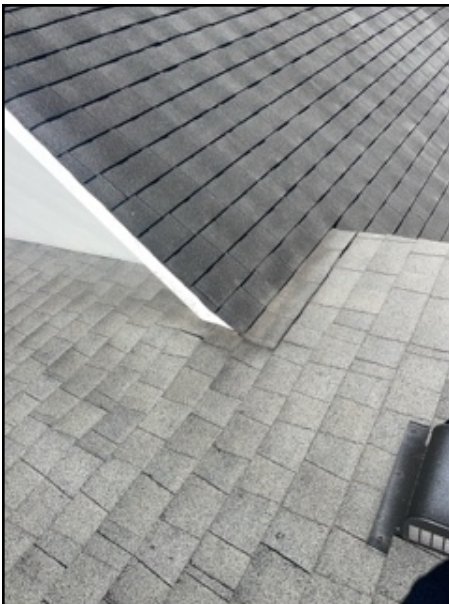
Figure 13-1

Comment 13:
Flat area is 35" wide.

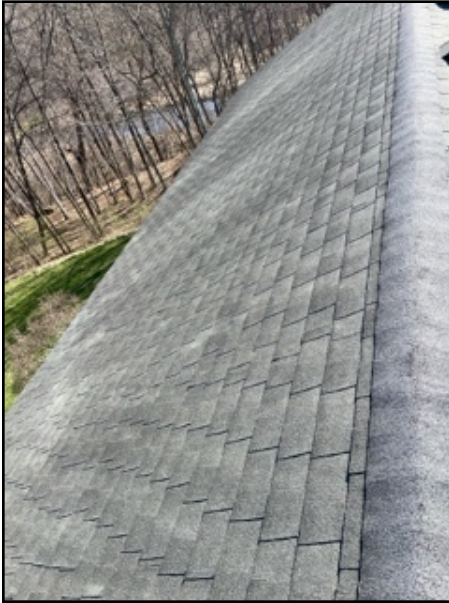
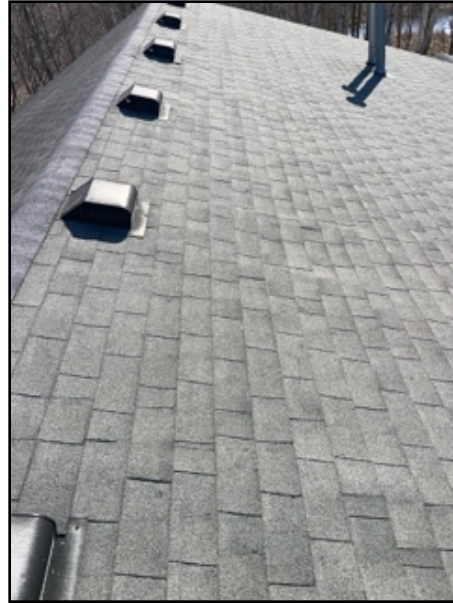
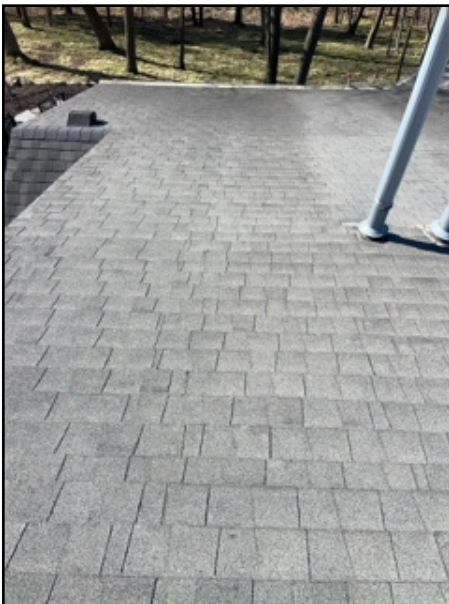
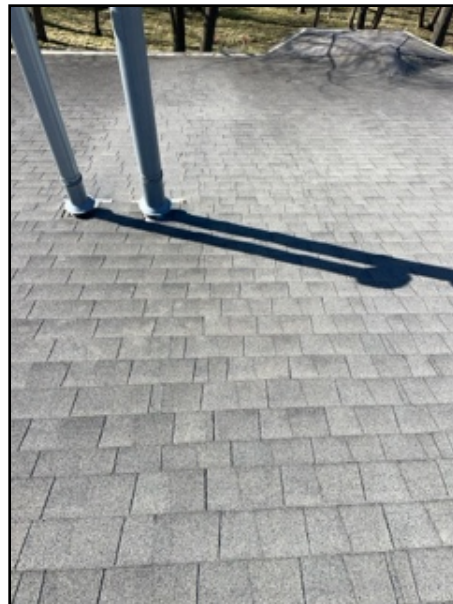
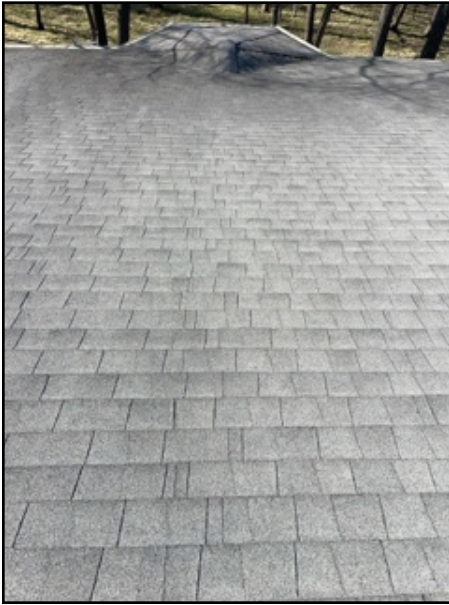
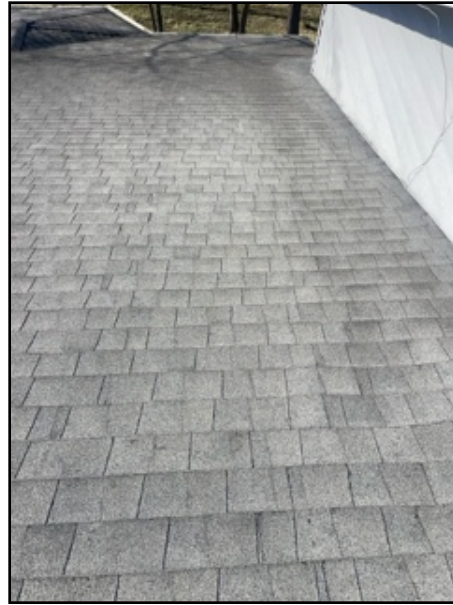
Comment 14:
The roof is in fair condition.

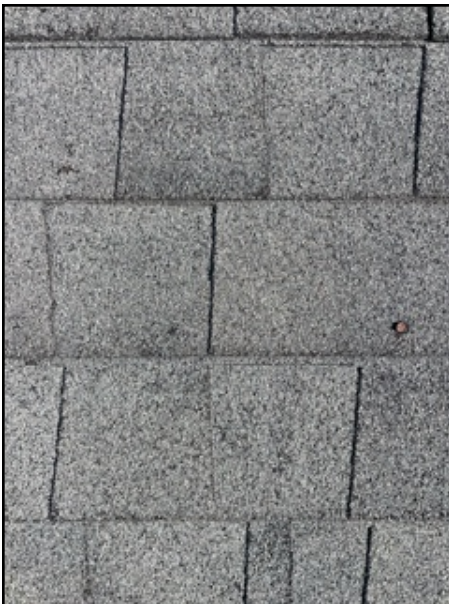
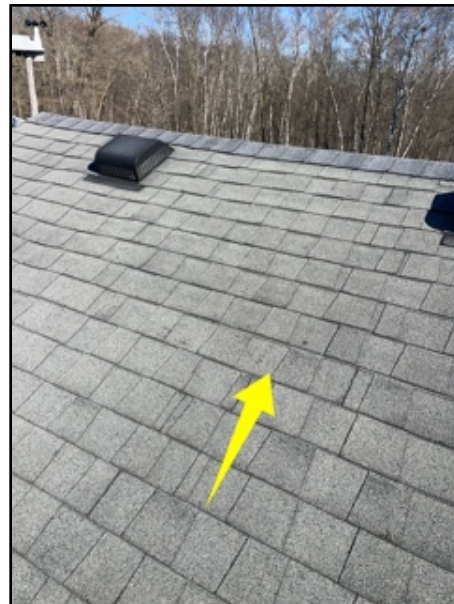
There are a few exposed nails.

3) There are a few exposed nails.

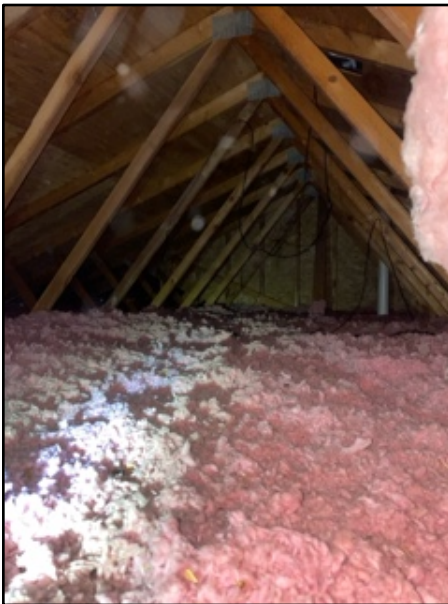
Figure 16-1

Comment 16:
12" of blown fiberglass.

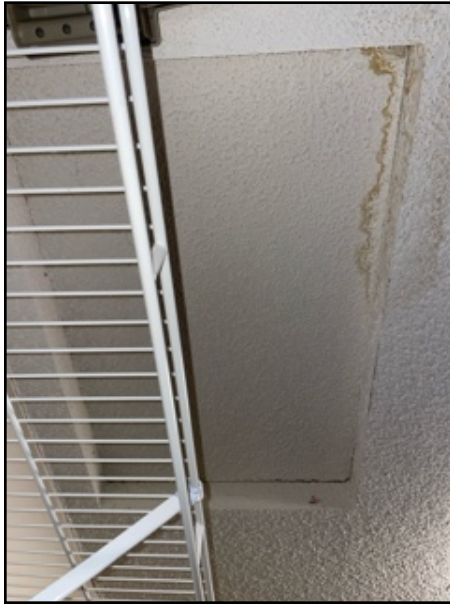
Figure 17-1

Water stain caused by no insulation above attic access where vapor condensation gathered

For better energy efficiency the batt insulation should be cut to fit the access and access should be caulked or weatherstripped.

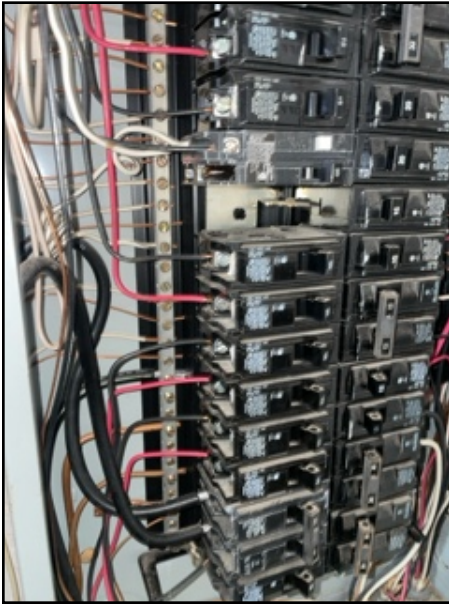
Figure 19-1

Comment 19:
Several wires share a common neutral
The breaker's should be tied together .

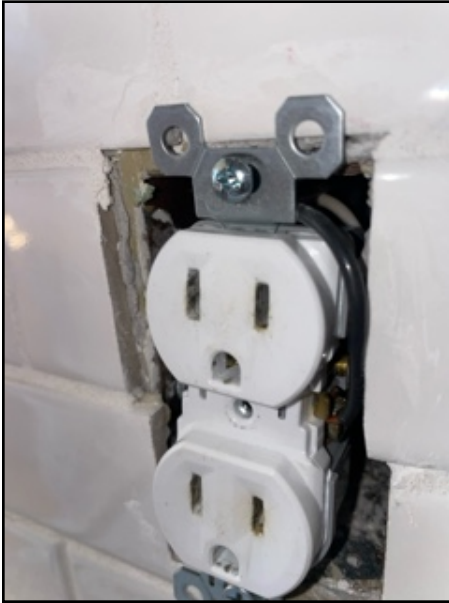
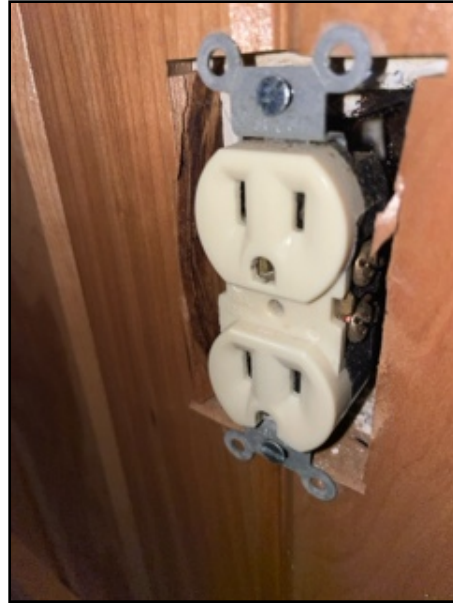
Outlet boxes should be extended through the wainscoting/tile/paneling/cabinet.

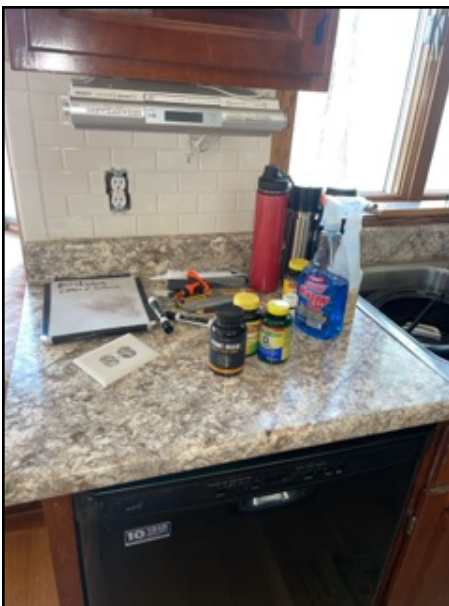
Figure 22-1

Outlet left of kitchen sink is loose .

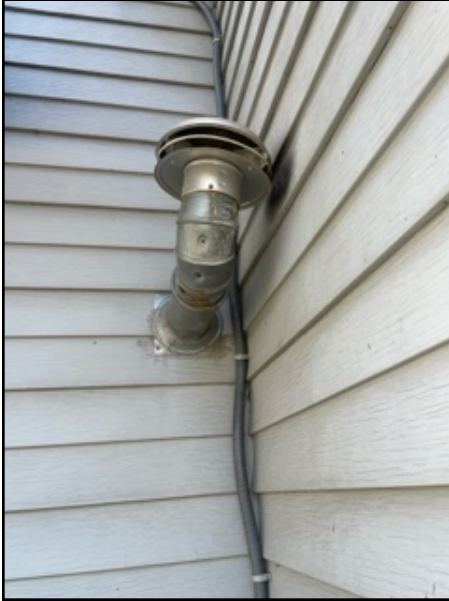
Figure 24-1

Check with manufacturer of garage heater for clearances.

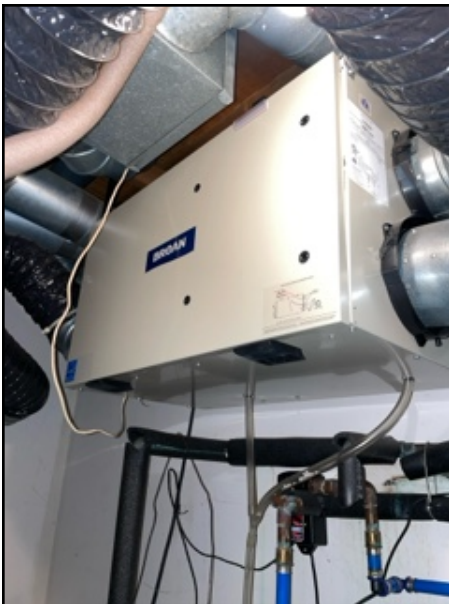
Figure 25-1

The filters in the air exchanger should be cleaned annually.

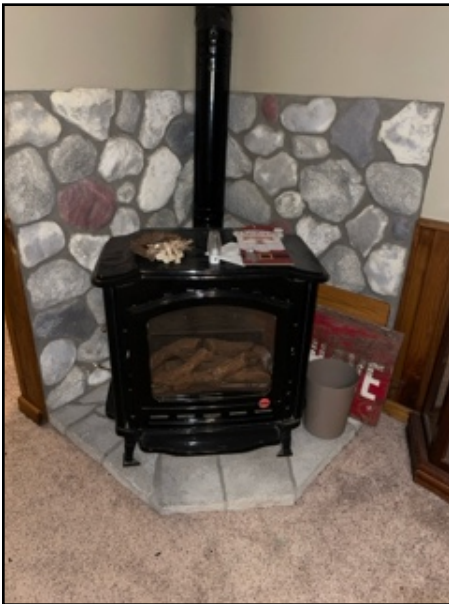
Figure 26-1

I did not operate the small fireplace in the basement .

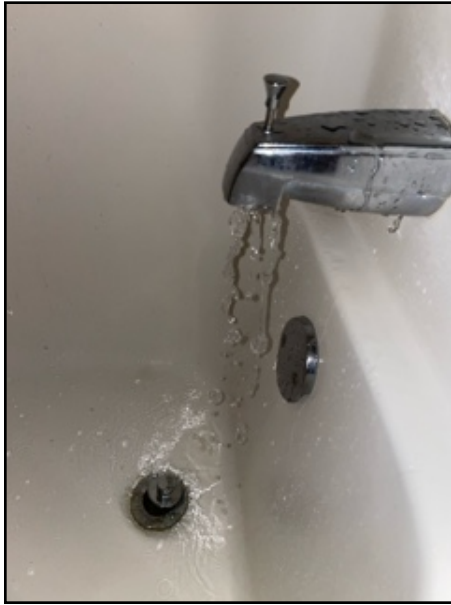
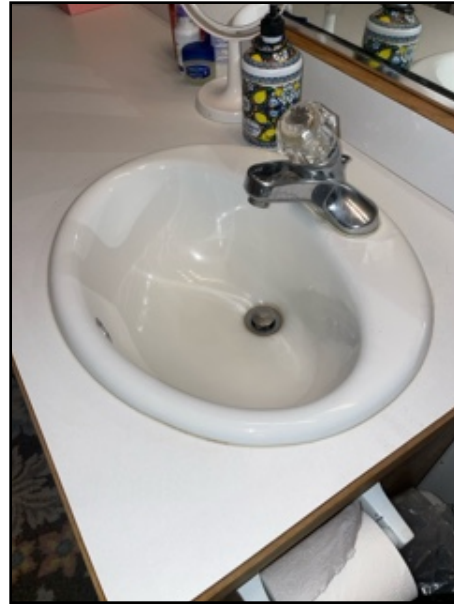
Comment 28:
Second floor main bathroom
Shower diverter does not divert all of the water
Sink stopper is not connected .

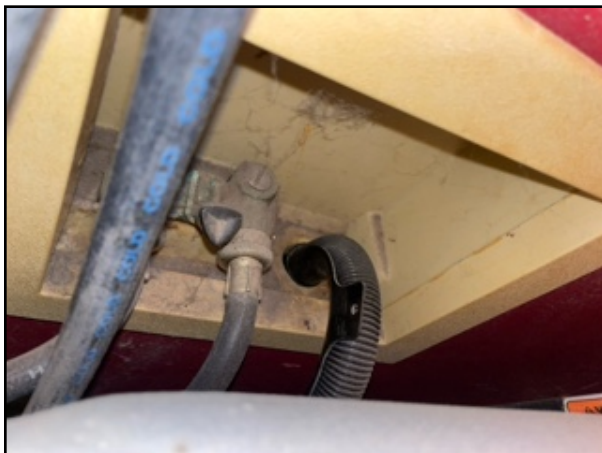
Figure 29-1

There should be air hammer arresters for the washer.

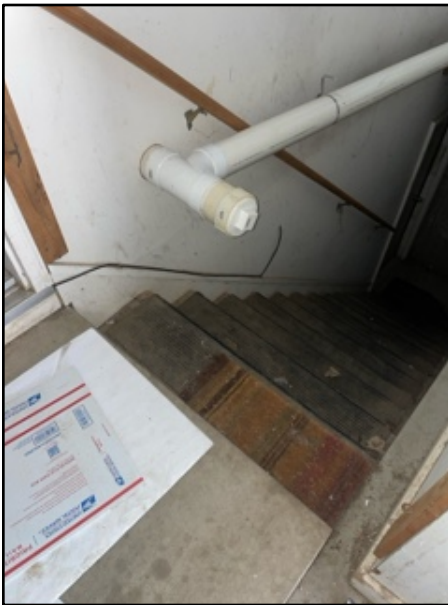
Figure 31-1

Comment 31:
Dryer vent pipe infringes on the stairway.

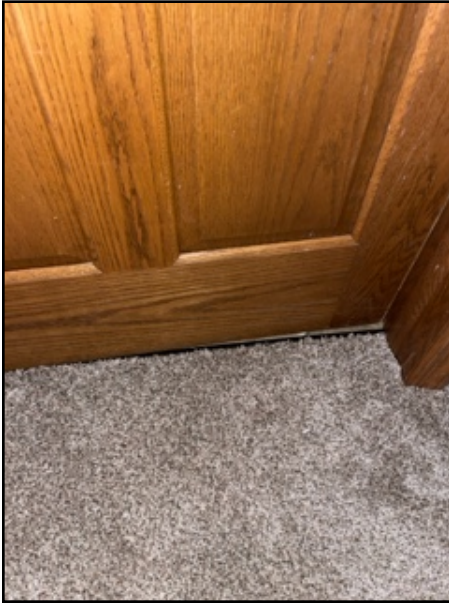
Figure 32-1

Master bathroom door does not close.

6) Master bathroom door does not close.

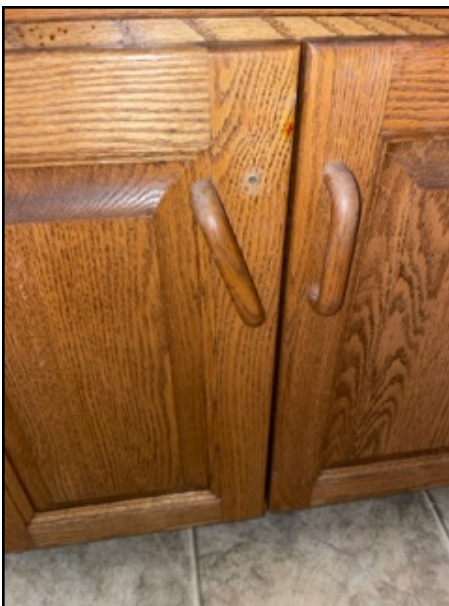
Figure 33-1

Master bathroom cabinet is missing a screw.

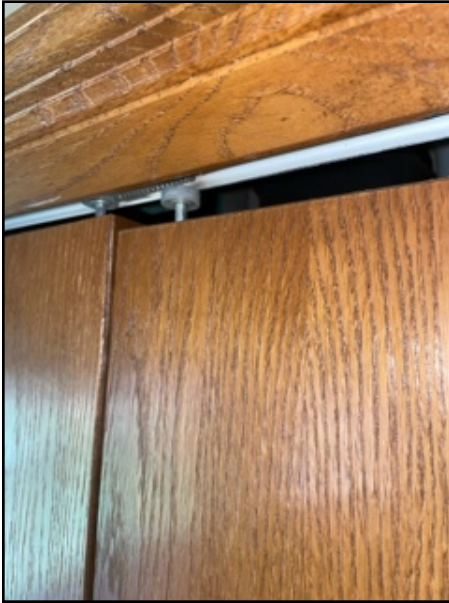
Figure 34-1

Bedroom closet needs to be adjusted .

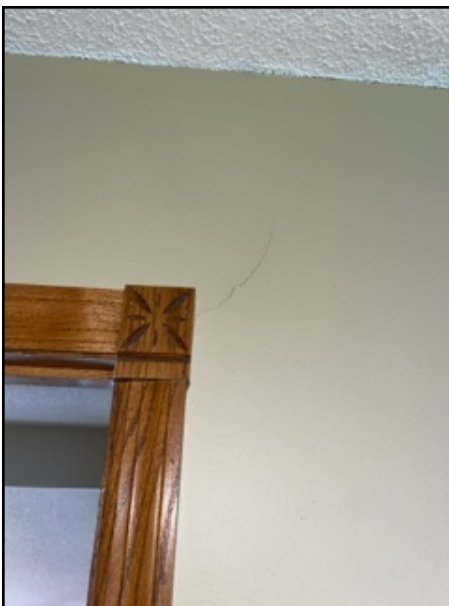
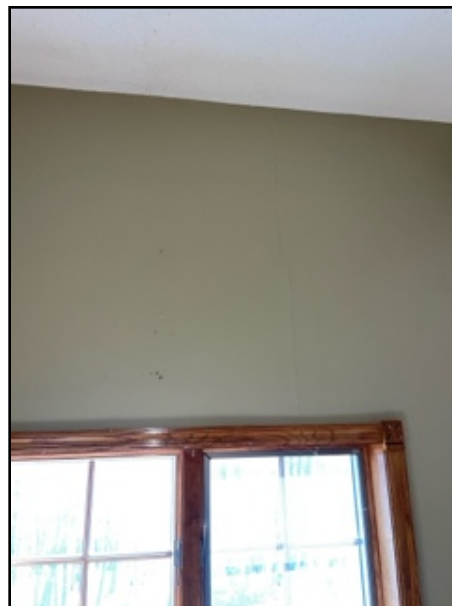
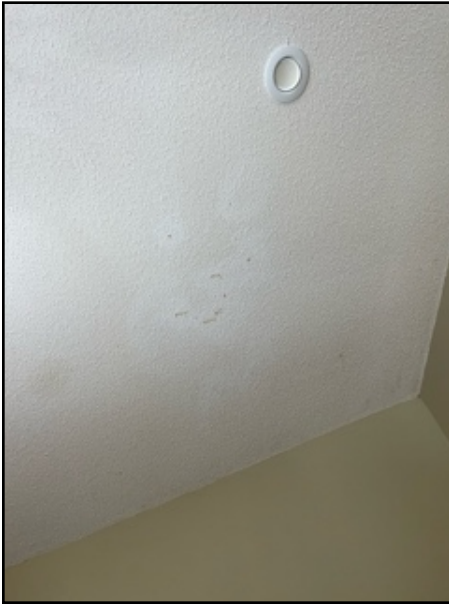
Some minor cracks in walls and ceilings.

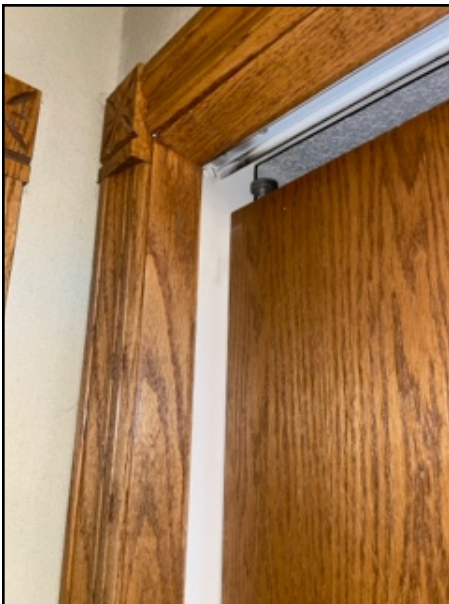
Figure 36-1

Closet door by garage entry needs to be adjusted .

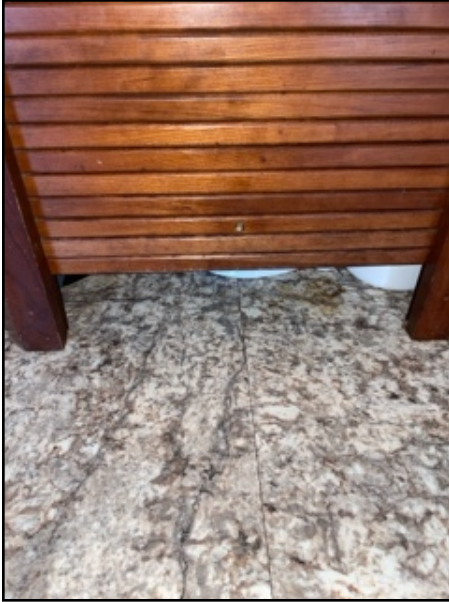
Figure 38-1

Comment 38:
Handle missing on appliance garage .

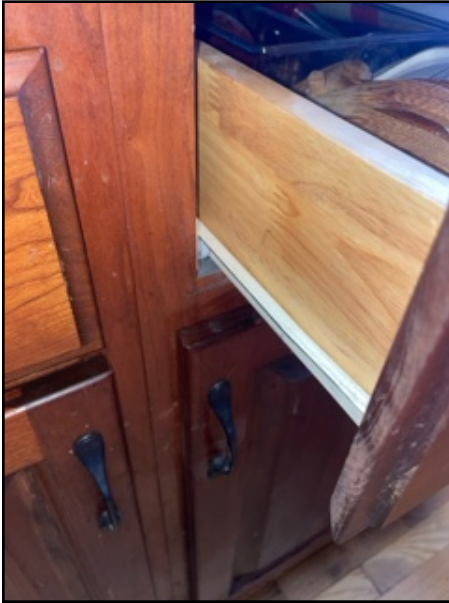
Figure 39-1

Drawer on island does not open and close properly .

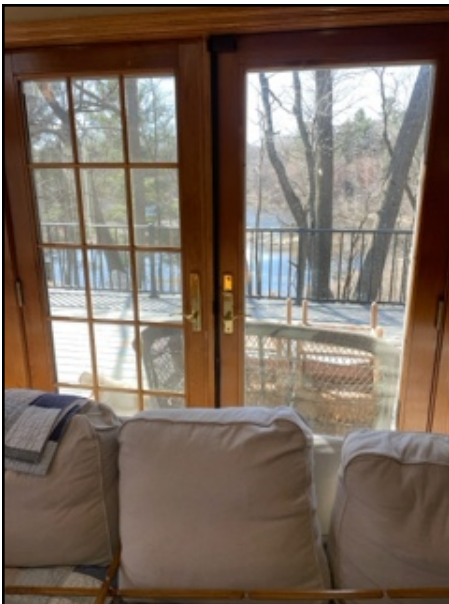
Figure 40-1

I could not get the left side of the French door to open
Right side was difficult to open and close .

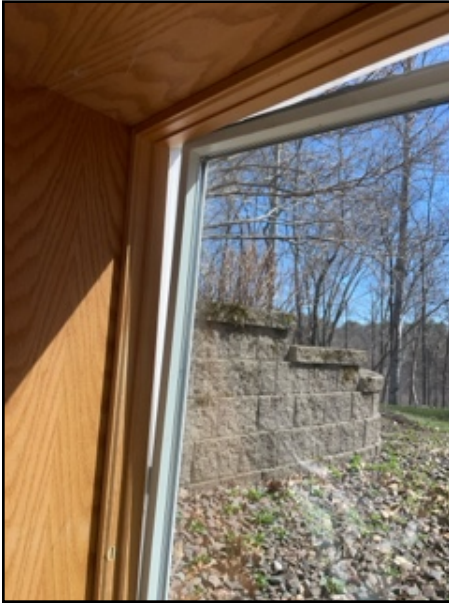
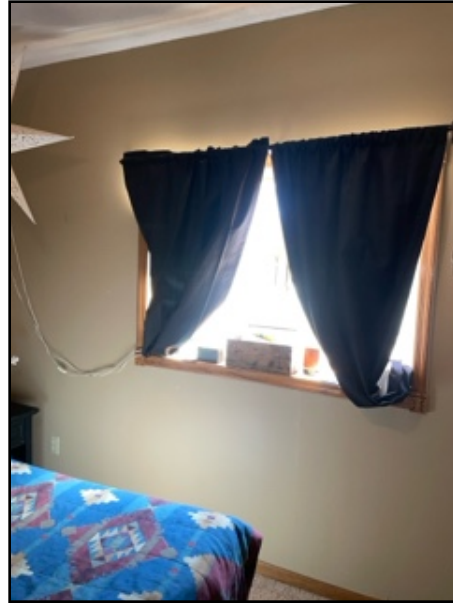
Comment 41:
Basement window is off its hinge .

7) Basement window is off its hinge .

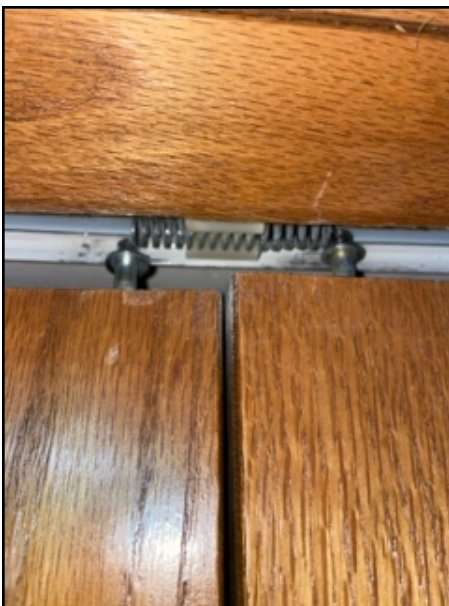
Figure 42-1

Comment 42:
Basement bedroom closet is missing some hardware .

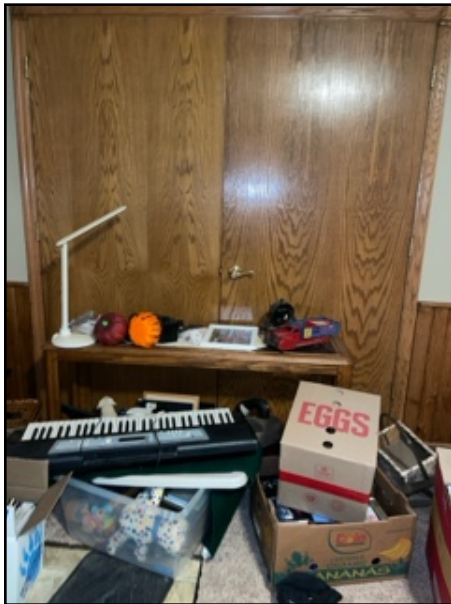
Figure 43-1

I did not open this closet in the basement .

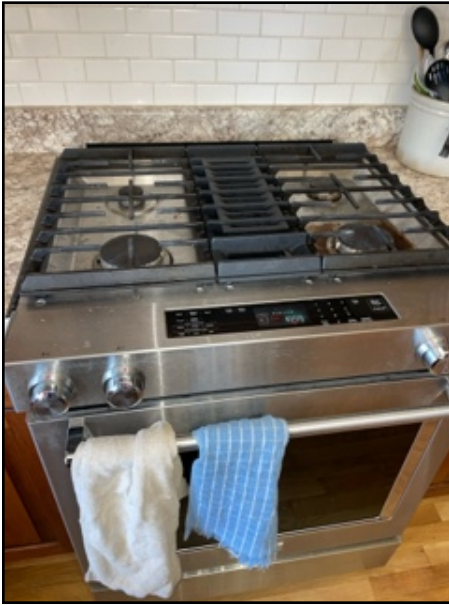
Figure 44-1

When the downdraft fan is on and the gas burners are on low the flame will go out causing a gas leak.
