IMPERIAL
INSPECTION SERVICES

Home Inspection Report

4642 215th St
Ames, IA 50014

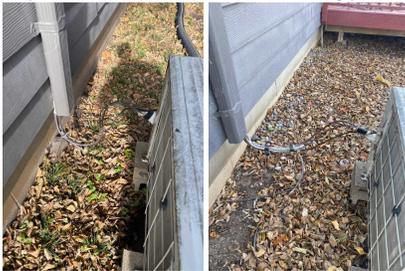
9. Marginal Refrigerant Lines: Line is drying out. Several areas are becoming uncovered. Recommend replacement as needed. Typical maintenance item

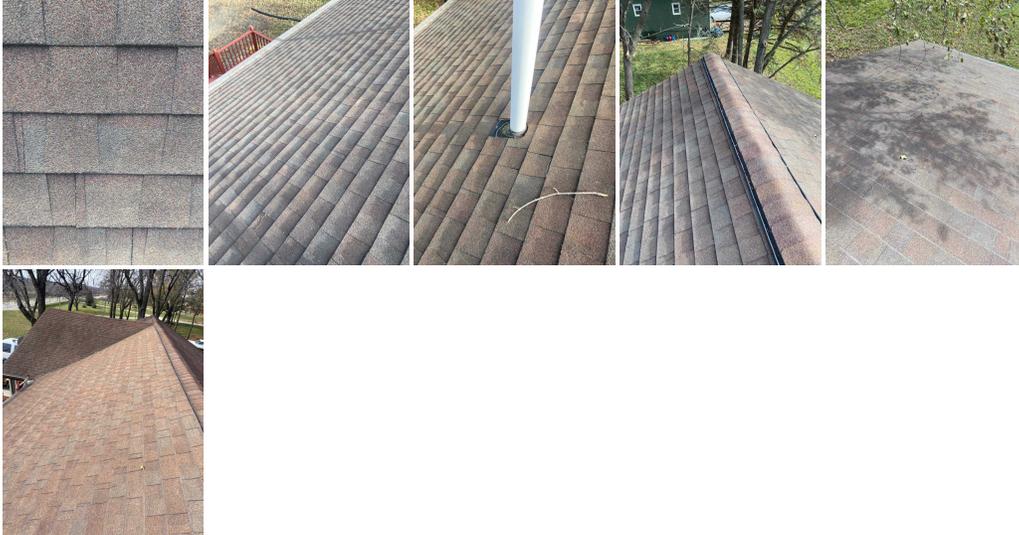
2. Acceptable Material: Asphalt shingle - Roof shows normal wear for its age and type. No damaged, deteriorated, or missing roofing materials were noted; appears to be in serviceable condition.

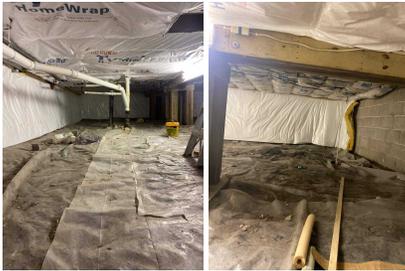
- 1. Method of Inspection: In the crawl space
- 2. Acceptable Access: Wood door

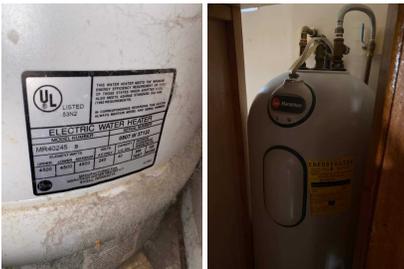
- 7. Acceptable Water Heater Operation: Adequate - Hot water was noted at all tested plumbing fixtures indicating the water heater elements were functioning properly at the time of inspection. These elements are not visible or assessable to the inspector and are not tested at the time of inspection. These elements can fail at any time without warning. No warranty, guarantee, or certification is given as to future failures.
- 8. Manufacturer: Marathon

- 9. Type: Electric Capacity: 40 Gal.
- 10. Approximate Age: Manufactured in 2005 Area Served: Whole building
- 11. Acceptable TPRV and Drain Tube:

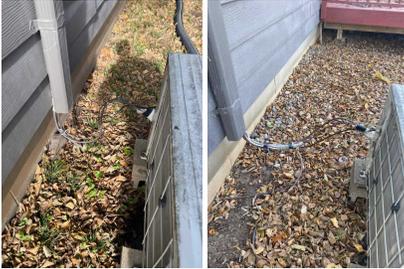
1. Main AC System Refrigerant Lines: Line is drying out. Several areas are becoming uncovered. Recommend replacement as needed. Typical maintenance item
