Bright Light Inspections LLC

Inspection Report

5250 S Emblem St
Derby, KS 67037

Inspected on Mon, Oct 19 2026 at 09:00

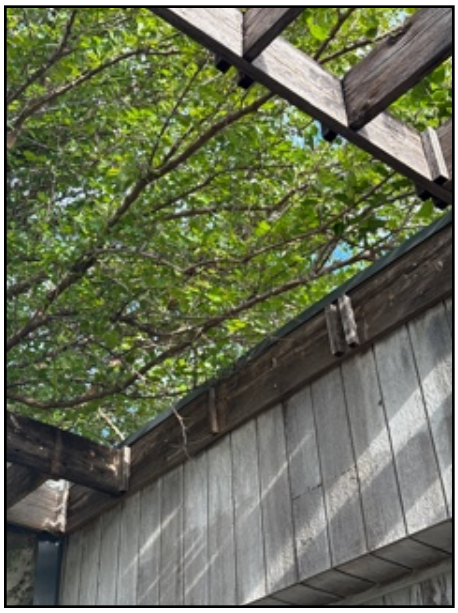
Figure 6-3

Comment 6:
Vegetation around the exterior walls was in contact with the home and siding. Inspector recommends trimming back or removing vegetation near walls to avoid damage to home.

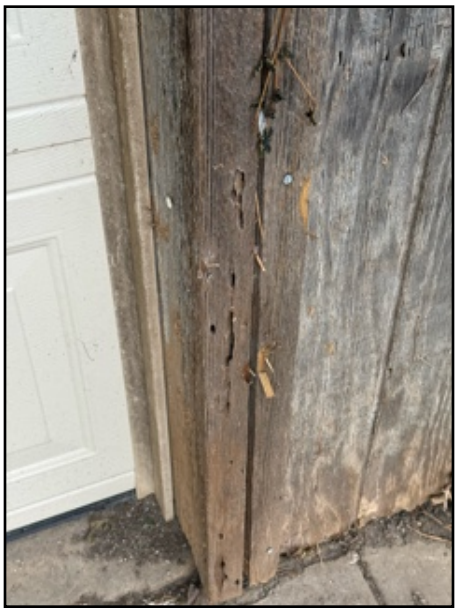
Figure 12-1

Comment 12:
Exterior trim was damaged, and sealant was missing at joints between the trim and siding and around windows, leaving these areas susceptible to moisture intrusion. After any siding or window repairs or replacement are completed, have a qualified contractor evaluate all exterior trim, repair or replace damaged sections, and seal joints where appropriate.

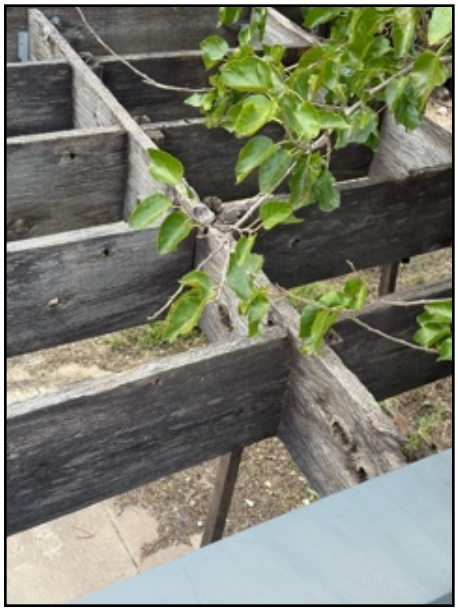
Figure 14-3

Comment 14:
The pergola over the front driveway and walkway was in overall poor condition, with significant deterioration and sections coming apart. This presents a potential falling-material or collapse hazard. Avoid parking or walking beneath it until a qualified contractor evaluates the structure and completes necessary repairs or removal.

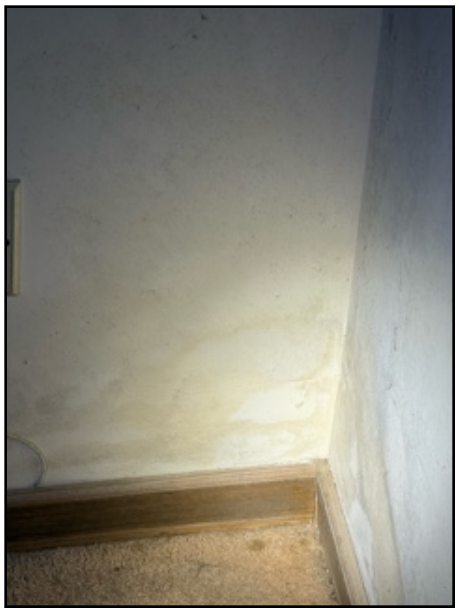
Figure 19-2

Comment 19:
Multiple areas of apparent fungal or microbial growth were found throughout the home, along with staining and damage suggesting prolonged roof leaks. Additional growth or moisture damage may be concealed behind walls, ceilings, or other finishes. The type and extent of growth and any associated health concerns could not be determined during this inspection. Have a qualified mold assessment professional evaluate the affected areas and recommend appropriate testing and remediation. Have qualified contractors identify and repair moisture sources and damaged materials.

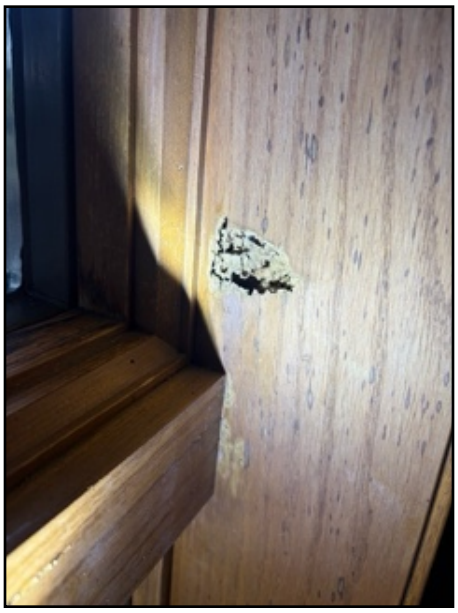
Figure 21-1

Comment 21:
Many of the windows throughout the home were wood-framed windows that showed signs of termite damage. Multiple window sills and frames had significant wood damage consistent with termite activity. The inspector recommends having all affected windows evaluated and repaired or replaced as needed, as well as having a licensed pest control professional inspect the home for active termite activity.

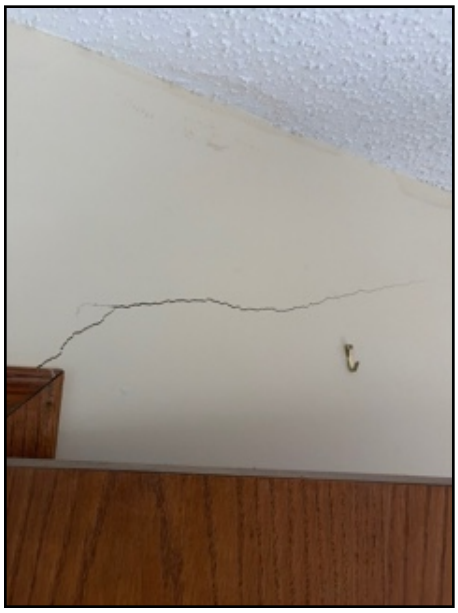
Figure 27-1

Comment 27:
A crack in the drywall was observed in this room. No other similar cracks were found throughout the home at the time of inspection. This crack indicates that some movement has occurred, which could be due to normal settlement over time or potential framing issues within the wall. The exact cause of the movement could not be determined at the time of inspection. The inspector recommends monitoring the crack for further movement or worsening conditions and consulting a qualified contractor if additional movement occurs.

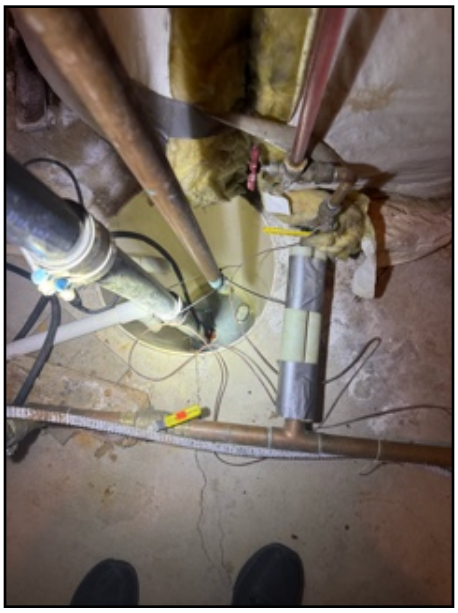
Figure 36-1

Comment 36:
The sump pump was located in a deep pit, and the float could not be reached to activate and test the pump. Pump operation could not be verified at the time of the inspection. Have a qualified plumber verify proper operation.

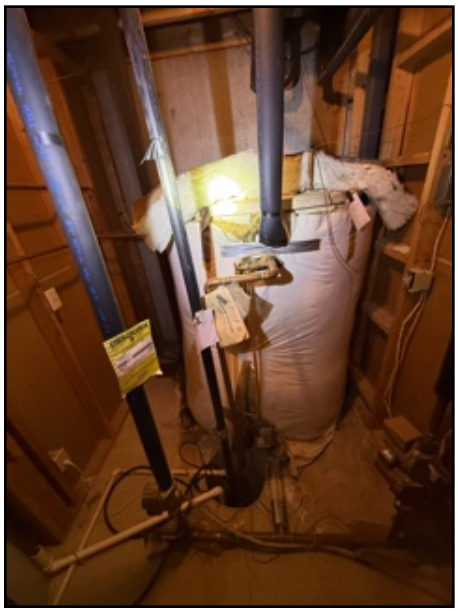
Figure 41-3

Comment 41:
The HVAC system appeared to include components from a previous geothermal system, which transfers heat through underground piping. Waterlines entering the indoor HVAC unit were shut off, and a large tank with circulation pumps was present in the mechanical room. These components appeared inactive. Moisture on the floor may indicate a leak, although the source was not confirmed. During heating operation, the rooftop outdoor unit operated, indicating the system was functioning as an air-source heat pump. Underground geothermal components are outside the scope of this inspection and were not evaluated. Have a licensed HVAC technician identify the current system configuration, determine whether any geothermal components remain operational, and locate and repair the source of moisture.

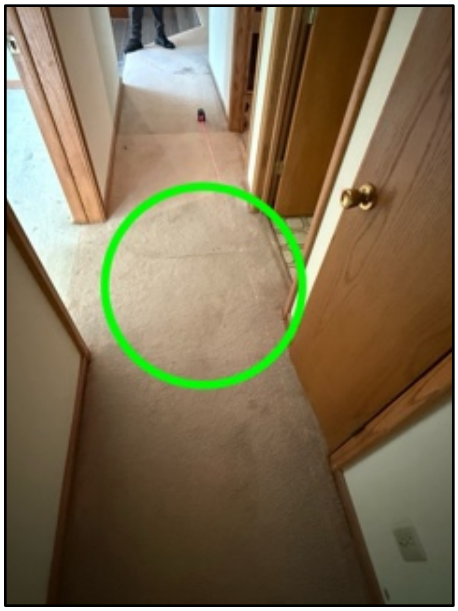
Figure 44-1

Comment 44:
The floor sloped downward toward the center hallway, with an estimated elevation difference of approximately 1/2 to 3/4 inch in the most noticeable areas. A visible slab crack in the mechanical room and nearby drywall cracking suggest settlement beneath the slab in this area. Have a qualified foundation contractor evaluate the settlement and determine whether repairs are necessary.
