# Bright Light Inspections LLC

## Inspection Report

**12220 N Seneca St  
Sedgwick, KS 67135**

Inspected on Wed, Aug 20 2025 at 08:30

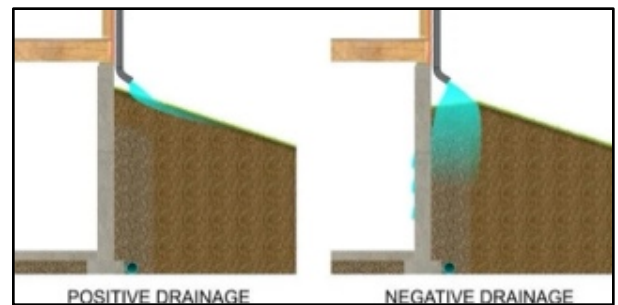
Figure 4-2

One or more downspouts discharged roof drainage next to the foundation. The inspector recommends installing downspout extensions to discharge roof drainage a minimum of 6 feet from the foundation.

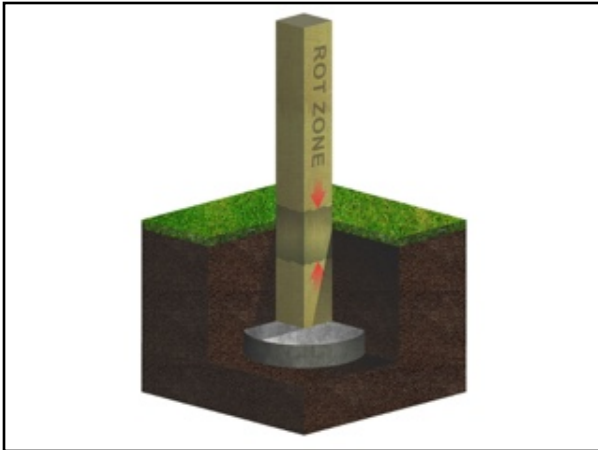
Figure 14-3

5) Comment 16: The deck had unconventional framing practices and had experienced some settlement and movement. The joists were over-spanned, were in the wrong orientation and had no joist hangers or band joist. This should be further evaluated by a qualified contractor to determine options and costs for any necessary repairs.
