SURVEY PLAT

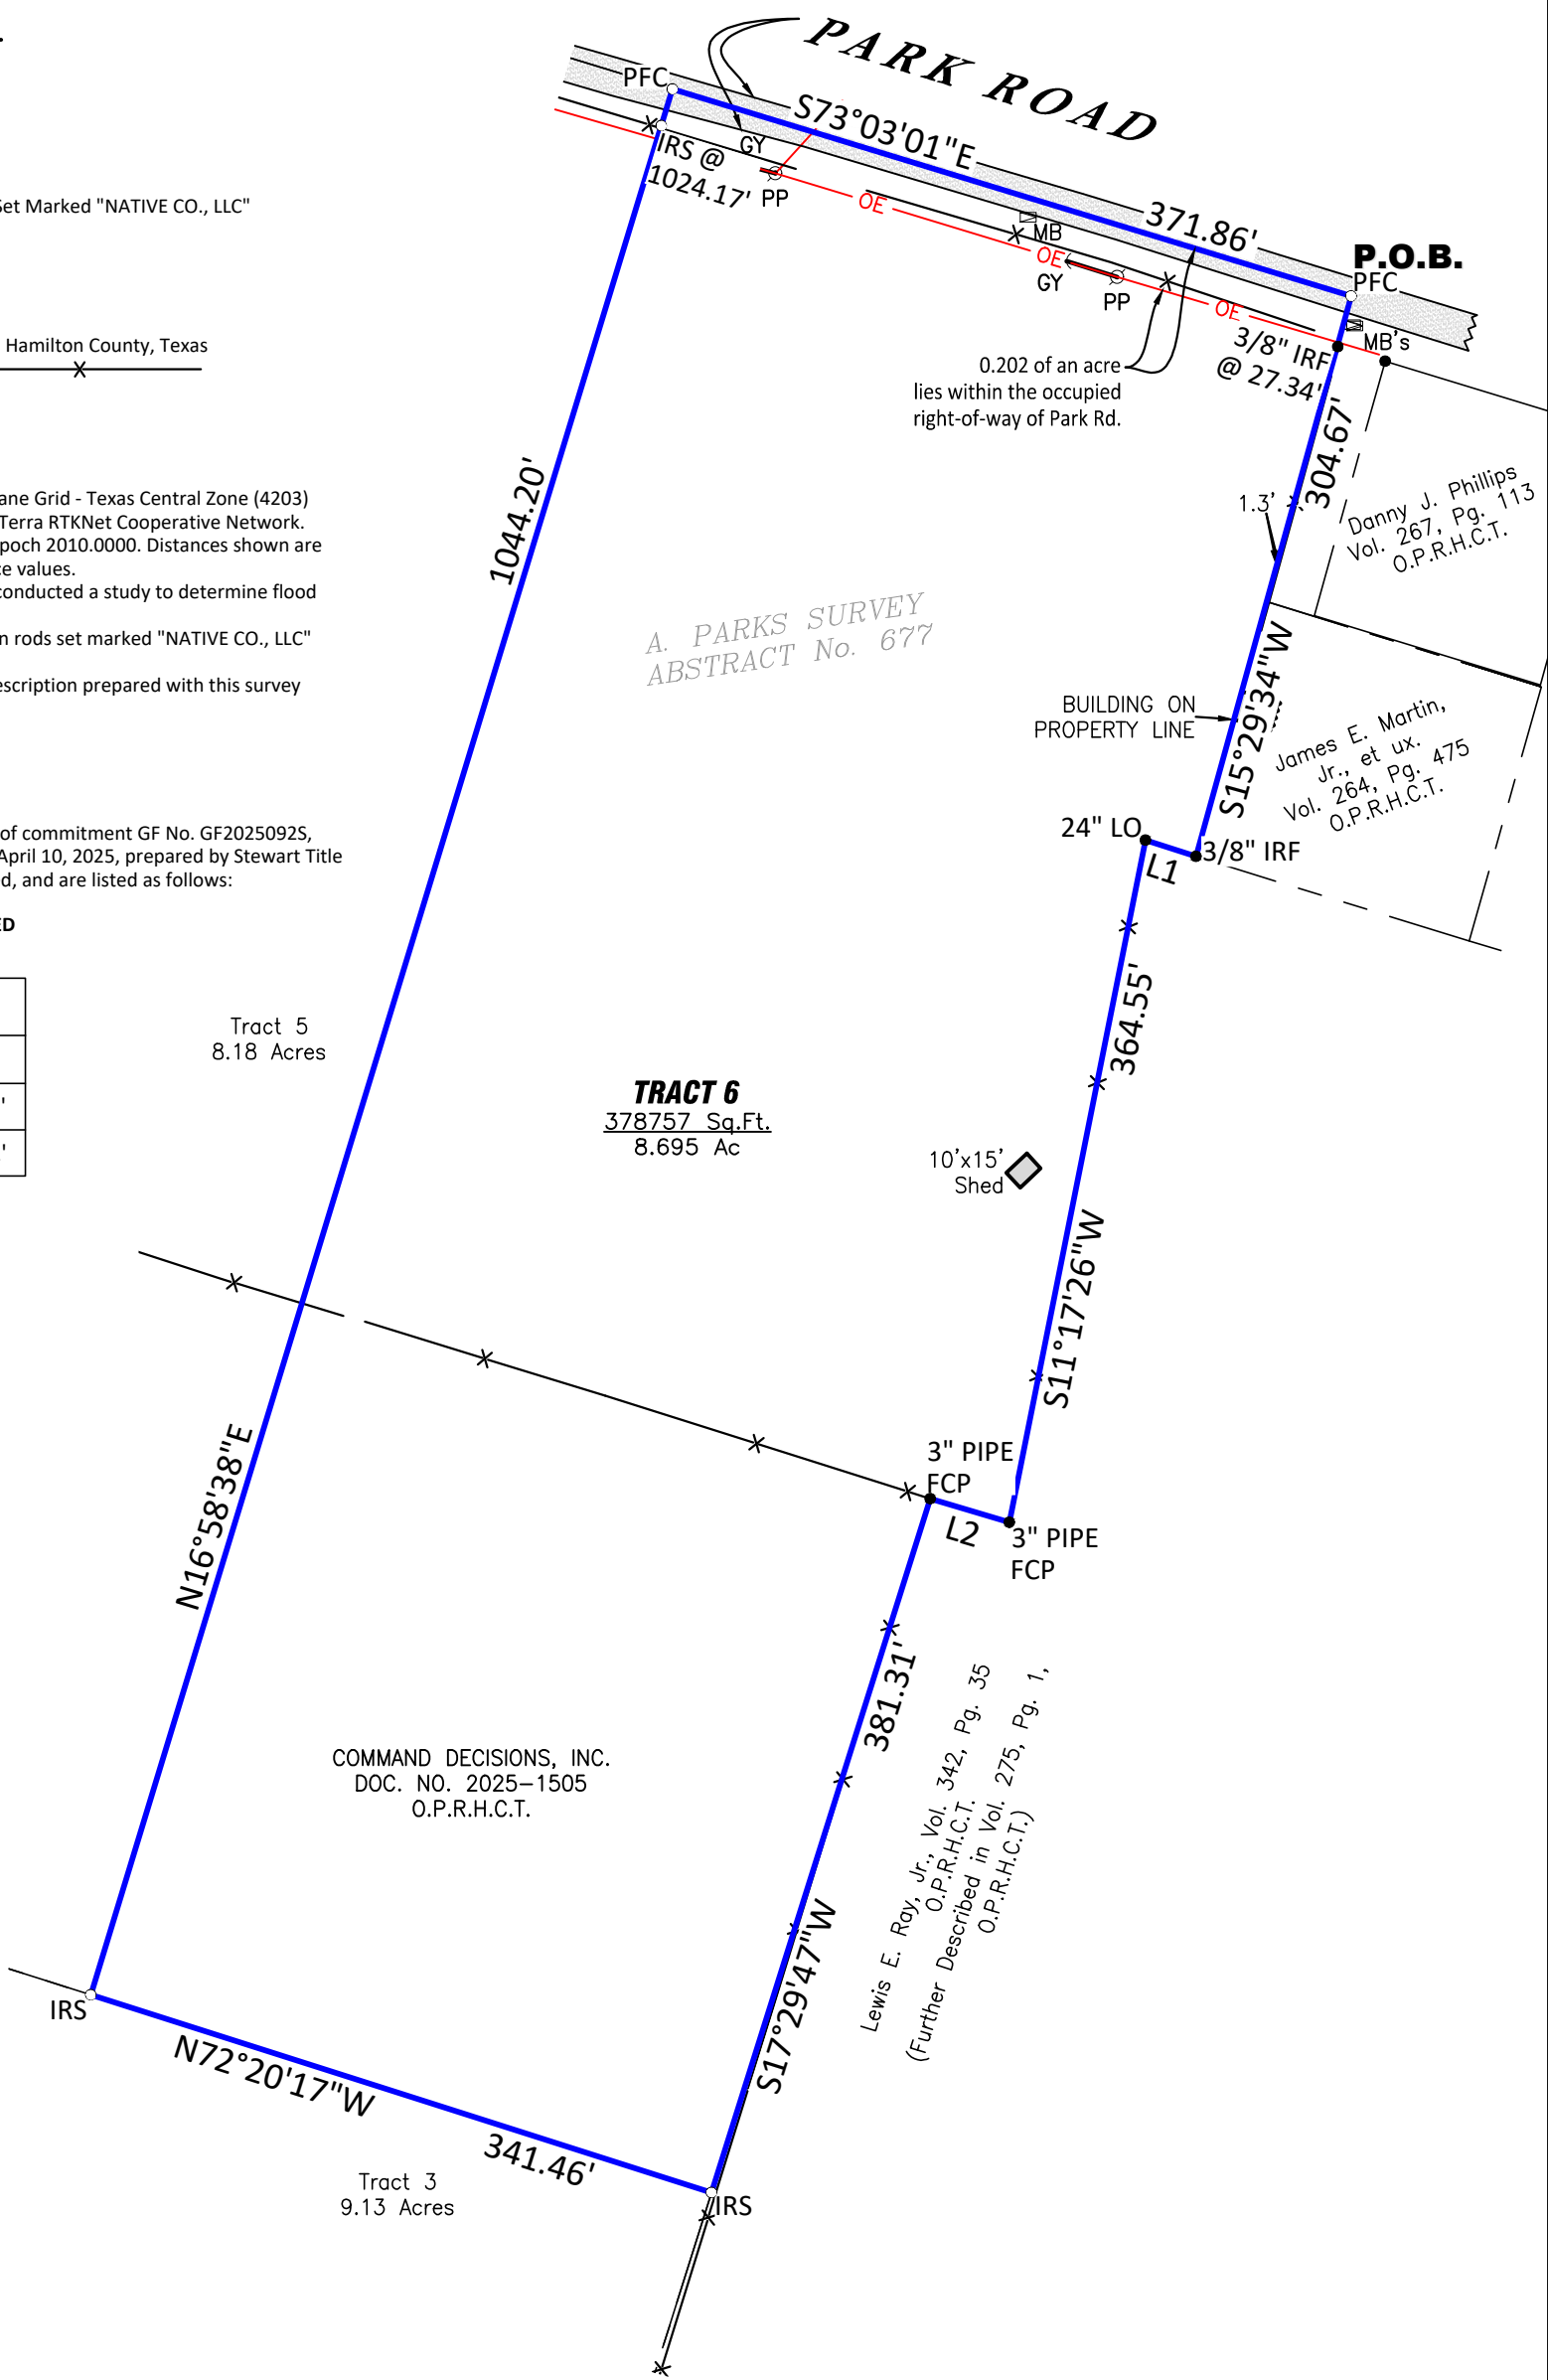
- 1. Basis of bearing being U.S. State Plane Grid - Texas Central Zone (4203) NAD83 as established using the AllTerra RTKNet Cooperative Network. Reference frame is NAD83(2011) Epoch 2010.0000. Distances shown are U.S. Survey feet displayed in surface values.
- 2. It does not appear that FEMA has conducted a study to determine flood hazard for this area at this time.
- 3. All corners are 5/8 inch capped iron rods set marked "NATIVE CO., LLC" unless otherwise noted.
- 4. See separate metes and bounds description prepared with this survey plat.
